## General Information

| Make | Toyota | Model | Vios |
| YOM | 2024 | Odo Meter Reading | 1,663 |
| Registration No. | NGC8864 | Chassis No. | PA1B23F31P6009114 |

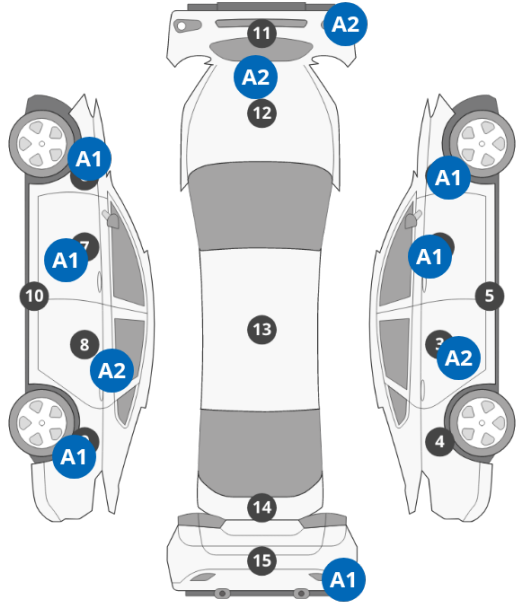
| Interior Evaluation : <span style="color: red; font-weight: bold;">A</span> | Exterior Evaluation : <span style="color: red; font-weight: bold;">B</span> |
| <b>Remarks</b><br>Defects not found | <b>Remarks</b><br>(R) Front Fender, Molding - Scratch - Minimal / (R) Front Door, Molding - Scratch - Minimal / (R) Rear Door, Molding - Scratch - Small / Rear Bumper, Lamps, Panels - Scratch - Minimal / (L) Rear Fender, Molding - Scratch - Minimal / (L) Rear Door, Molding - Scratch - Small / (L) Front Door, Molding - Scratch - Minimal / (L) Front Fender, Molding - Scratch - Minimal / Front Bumper, Grille, Lamps - Scratch - Small / Bonnet, Headlight - Scratch - Small |

| Inspector Notes |
|---|
| no warranty booklet, with jack and tools, with spare tire, with LTO plate, scratches on tail light |
