## General Information

| Make | Toyota | Model | Vios |
| Registration No. | NHS2015 | Chassis No. | PA1B18F37R4251887 |

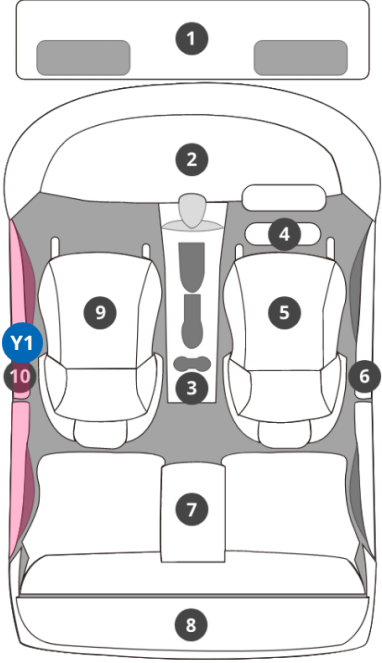
| Interior Evaluation : <b>A</b> | Exterior Evaluation : <b>B</b> |
|---|---|
| <b>Remarks</b><br>(L) Front Trim - Grime - Minimal | <b>Remarks</b><br>(R) Front Fender - Repair Traces - Yes / (R) Mirror - Scratch - Small / (R) Front Door, Molding - Scratch - Minimal / Trunk Hood, Rear Gate - Scratch - Minimal / (L) Rear Door, Molding - Scratch - Minimal / (L) Mirror - Scratch - Small / Front Bumper, Grille, Lamps - Scratch & Dent - Medium |
