## General Information

| Make | Toyota | Model | Vios |
| Registration No. | NKB5742 | Chassis No. | PA1B18F39R4249364 |

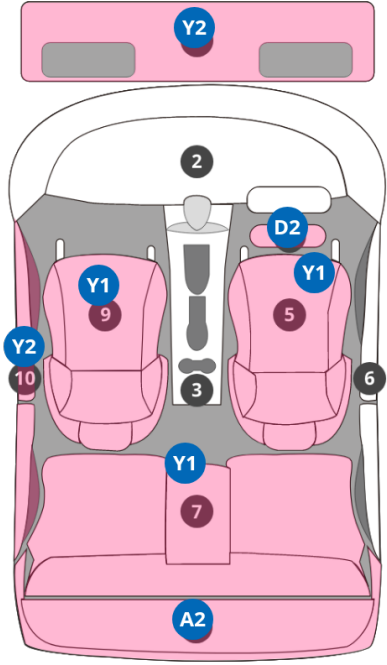
| Interior Evaluation : <b>B</b> | Exterior Evaluation : <b>B</b> |
|---|---|
| <p><b>a</b> : Cut, Fray <b>d</b> : Loose, Deformed <b>k</b> : Animal Hair <b>s</b> : Smell <b>t</b> : Cigarette Burns <b>x</b> : Defective <b>y</b> : Stain</p> | <p><b>A</b> : Scratch <b>AU</b> : Scratch &amp; Dent <b>B</b> : Modified <b>C</b> : Corrosion <b>G</b> : Stone chip <b>P</b> : Faded <b>S</b> : Rust <b>SC</b> : Rust &amp; Corrosion <b>U</b> : Dent <b>X</b> : Defective <b>Y</b> : Crack, Gap</p> |
| <p><b>Remarks</b></p> <p>Trunk Room - Worn, Scratch, Cut, Crack - Small / Rear Seat - Grime - Minimal / Ceiling - Grime - Small / (R) Front Seat - Grime - Minimal / (L) Front Trim - Grime - Small / (L) Front Seat - Grime - Minimal / (L) Front Floor Mat - Worked - Small</p> | <p><b>Remarks</b></p> <p>(R) Front Fender, Molding - Scratch - Minimal / (R) Front Door, Molding - Scratch - Minimal / (R) Rear Door, Molding - Scratch - Minimal / (R) Rear Fender, Molding - Scratch - Minimal / Rear Bumper, Lamps, Panels - Scratch - Small / Trunk Hood, Rear Gate - Scratch - Minimal / (L) Rear Fender, Molding - Scratch - Minimal / (L) Rear Door, Molding - Scratch - Minimal / (L) Front Door, Molding - Scratch - Minimal / Roof - Dent - Minimal / (L) Front Fender, Molding - Scratch - Minimal / Front Bumper, Grille, Lamps - Scratch - Minimal / Bonnet, Headlight - Scratch - Minimal</p> |
