## General Information

| Make | Toyota | Model | Yaris Cross |

## Body / Panel Condition

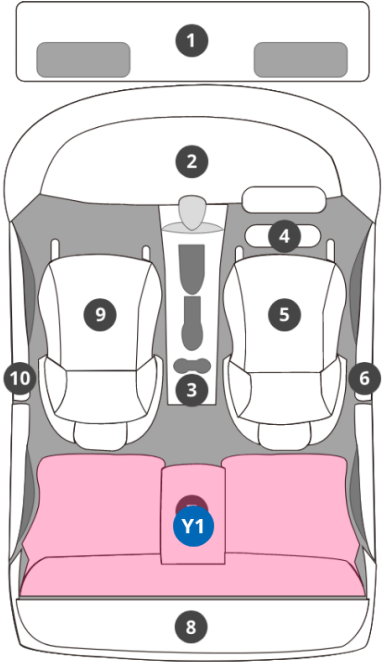
| <b>Interior Evaluation :</b> <b>A</b> | <b>Exterior Evaluation :</b> <b>B</b> |
| <b>Remarks</b><br>Rear Seat - Grime - Minimal | <b>Remarks</b><br>(R) Front Fender, Molding - Scratch - Small / (R) Front Door, Molding - Scratch - Small / (R) Rear Fender, Molding - Scratch - Minimal / Rear Bumper, Lamps, Panels - Scratch - Minimal / (L) Rear Door, Molding - Scratch - Minimal / (L) Rear Fender, Molding - Scratch - Minimal / (L) Front Door, Molding - Scratch - Minimal / (L) Mirror - Scratch - Minimal / (L) Front Fender, Molding - Scratch - Minimal / Front Bumper, Grille, Lamps - Scratch - Small / (R) Rear Door, Molding - Scratch & Dent - Minimal / Roof - Scratch - Minimal / Bonnet, Headlight - Scratch - Minimal |
