## General Information

| Make | Toyota | Model | Rush |

## Body / Panel Condition

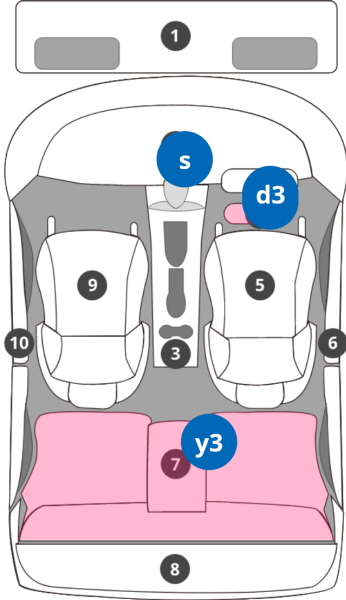
| Interior Evaluation : <b>B</b> | Exterior Evaluation : <b>C</b> |
|---|---|
| <b>Remarks</b><br>Overall Interior - Smell - Yes / (L) Front Floor Mat - Cut, Crack - Medium / (R) Front Floor Mat - Crinkle - Medium / Rear Seat - Grime - Medium | <b>Remarks</b><br>(L) Front Door - Repair Traces - Yes / Trunk Hood, Rear Gate - Repair Traces - Yes / (L) Rear Door, Molding - Scratch - Medium / (L) Front Door, Molding - Scratch & Dent - Minimal / (L) Mirror - Scratch, Peeled - Minimal / Front Bumper, Grille, Lamps - Scratch - Large / (R) Mirror - Scratch - Minimal / (R) Rear Door, Molding - Scratch - Medium / Trunk Hood, Rear Gate - Scratch - Medium / Rear Bumper, Lamps, Panels - Dent - Medium |

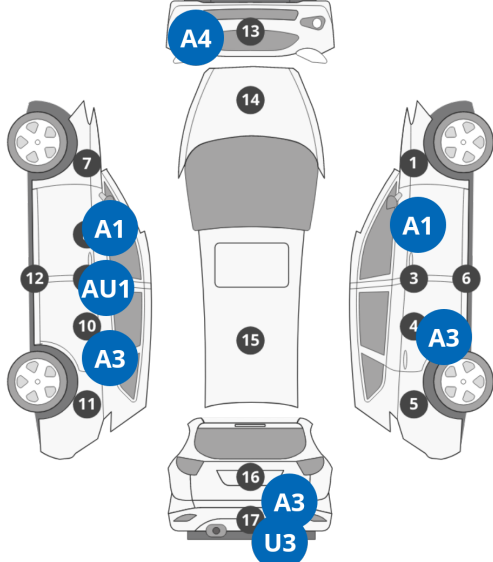
swirl marks and hairline scratches/ adhesive marks on the front windshield/
