## General Information

| Make | Toyota | Model | Vios |

## Body / Panel Condition

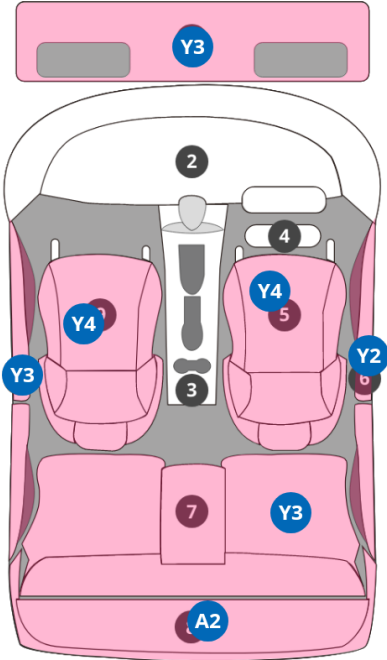
| Interior Evaluation : <span style="color: red;">C</span> | Exterior Evaluation : <span style="color: red;">E</span> |
|---|---|
| <b>Remarks</b><br>(L) Front Trim - Grime - Medium / (L) Front Seat - Grime - Large / Ceiling - Grime - Medium / Trunk Room - Worn, Scratch, Cut, Crack - Small / Rear Seat - Grime - Medium / (R) Front Seat - Grime - Large / (R) Front Trim - Grime - Small / Overall Interior - Worn as per age - Yes | <b>Remarks</b><br>(R) Front Fender, Molding - Dent - Medium / (R) Step, In-panel, Side Spoiler - Scratch & Dent - Medium / (R) Mirror - Scratch - Small / (R) Front Door, Molding - Scratch - Small / (R) Rear Door, Molding - Scratch & Dent - Small / (R) Rear Fender, Molding - Scratch & Dent - Small / Rear Bumper, Lamps, Panels - Scratch - Small / Trunk Hood, Rear Gate - Scratch - Minimal / (L) Rear Fender, Molding - Scratch - Small / (L) Rear Door, Molding - Scratch - Small / (L) Front Door, Molding - Scratch - Medium / Roof - Scratch - Small / (L) Mirror - Scratch - Minimal / (L) Front Fender, Molding - Scratch - Minimal / Front Bumper, Grille, Lamps - Repair mark - Yes / Front Bumper, Grille, Lamps - Crack, Gap - Large / Bonnet, Headlight - Scratch - Minimal |
