## General Information

| Make | Toyota | Model | Vios |
| YOM | 2021 | Odo Meter Reading | 66,576 |
| Registration No. | NFQ6626 | Chassis No. | PA1B18F36M4136903 |

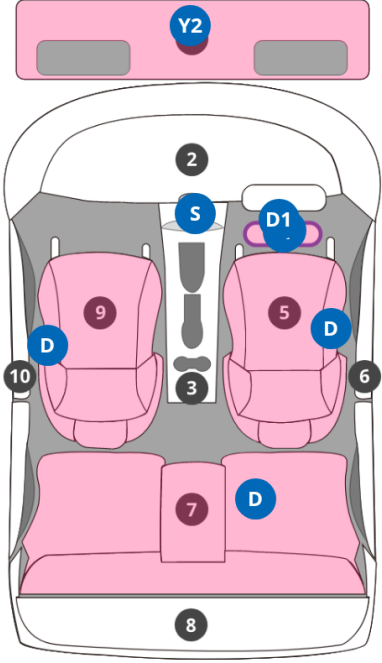
| Interior Evaluation : <b>C</b> | Exterior Evaluation : <b>E</b> |
|---|---|
| <p><b>a</b> : Cut, Fray <b>d</b> : Loose, Deformed <b>k</b> : Animal Hair <b>s</b> : Smell <b>t</b> : Cigarette Burns <b>x</b> : Defective <b>y</b> : Stain</p> | <p><b>A</b> : Scratch <b>AU</b> : Scratch &amp; Dent <b>B</b> : Modified <b>C</b> : Corrosion <b>G</b> : Stone chip <b>P</b> : Faded <b>S</b> : Rust <b>SC</b> : Rust &amp; Corrosion <b>U</b> : Dent <b>X</b> : Defective <b>Y</b> : Crack, Gap</p> |
| <p><b>Remarks</b></p> <p>(R) Front Floor Mat - Worked - Large / Overall Interior - Worn as per age - Yes / (L) Front Seat - Worn - Yes / (L) Front Floor Mat - Missing - Yes / Overall Interior - Smell - Yes / Ceiling - Grime - Small / Carpet - Worked - Minimal / (R) Front Seat - Worn - Yes / Rear Seat - Worn - Yes</p> | <p><b>Remarks</b></p> <p>(L) Front Fender - Repair Traces - Yes / Trunk Hood, Rear Gate - Repair Traces - Yes / (R) Front Fender, Molding - Scratch - Small / (R) Front Door, Molding - Scratch &amp; Dent - Small / (R) Rear Door, Molding - Scratch &amp; Dent - Large / (R) Step, In-panel, Side Spoiler - Scratch &amp; Dent - Medium / (R) Rear Fender, Molding - Scratch &amp; Dent - Medium / Rear Bumper, Lamps, Panels - Repair mark - Yes / Rear Bumper, Lamps, Panels - Scratch - Medium / Trunk Hood, Rear Gate - Dent - Medium / (L) Rear Door, Molding - Scratch - Medium / (L) Rear Fender, Molding - Scratch &amp; Dent - Small / (L) Mirror - Scratch - Small / Front Bumper, Grille, Lamps - Repair mark - Yes / Front Bumper, Grille, Lamps - Scratch - Medium / (R) Front Wheel, Cover - Cap Missing - Yes / (L) Front Fender, Molding - Crack, Gap - Medium / Bonnet, Headlight - Scratch - Small / (L) Front Door, Molding - Scratch - Small / (R) Mirror - Scratch - Minimal</p> |

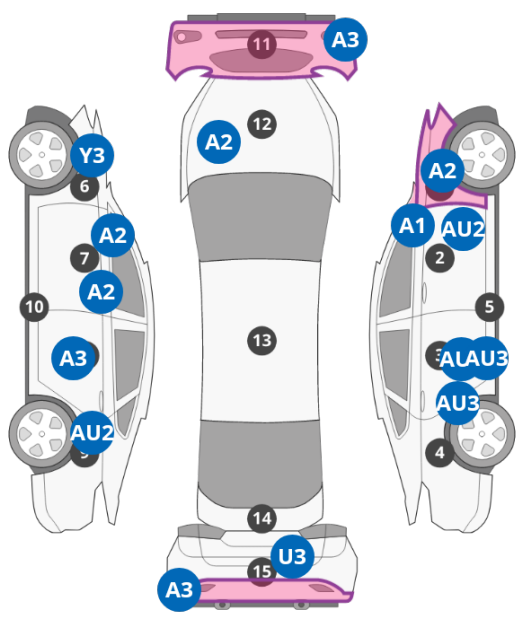
| Inspector Notes |
|---|
| <p>with warranty booklet, no jack, incomplete tools, with spare tire no rims, with LTO plate, scratches on tail light and headlight, cracked headlight, missing trunk floor mat, loose rear seat, adhesive marks on overall exterior, with dash cam wire no cam, loose head unit</p> |
