## General Information

| Make | Toyota | Model | Vios |
| YOM | 2024 | Odo Meter Reading | 16,498 |
| Registration No. | NFR8581 | Chassis No. | PA1B18F31R4258852 |

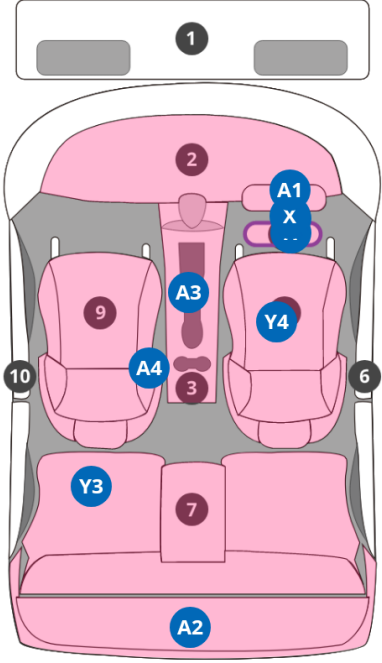
| Interior Evaluation : <b>C</b> | Exterior Evaluation : <b>E</b> |
| <p><b>Remarks</b></p> <p>Trunk Room - Worn, Scratch, Cut, Crack - Small / Rear Seat - Grime - Medium / Mat Other - Missing - Yes / (L) Front Floor Mat - Missing - Yes / (R) Front Floor Mat - Missing - Yes / (L) Front Seat - Cut, Crack - Large / Knobs - Worn, Peel, Crack - Medium / (R) Front Seat - Grime - Large / Glove Box - Worn, Scratch, Cut, Crack - Minimal</p> | <p><b>Remarks</b></p> <p>(L) Front Fender - Repair Traces - Yes / (L) Front Door - Repair Traces - Yes / (L) Rear Door - Repair Traces - Yes / (L) Rear Fender - Repair Traces - Yes / Trunk Hood, Rear Gate - Repair Traces - Yes / (L) Front Fender, Molding - Repair mark - Yes / (L) Front Door, Molding - Repair mark - Yes / (L) Rear Door, Molding - Repair mark - Yes / (L) Rear Fender, Molding - Repair mark - Yes / (R) Front Fender, Molding - Scratch - Minimal / (R) Front Door, Molding - Scratch - Small / (R) Rear Door, Molding - Scratch - Small / (R) Rear Fender, Molding - Scratch - Small / Rear Bumper, Lamps, Panels - Scratch &amp; Dent - Small / Trunk Hood, Rear Gate - Dent - Large / (L) Rear Fender, Molding - Scratch - Small / (L) Rear Door, Molding - Scratch &amp; Dent - Medium / (L) Front Door, Molding - Scratch &amp; Dent - Medium / (L) Mirror - Crack - Damaged / (L) Front Fender, Molding - Scratch - Small / Front Bumper, Grille, Lamps - Scratch &amp; Dent - Medium / Bonnet, Headlight - Scratch &amp; Dent - Small / Roof - Scratch - Small</p> |
