## General Information

| Make | Toyota | Model | Hiace |
| Registration No. | CAV6326 | Chassis No. | JTFNAFAP8L8015912 |

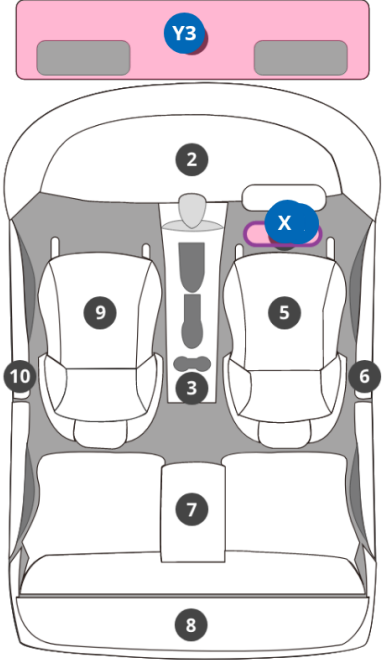
| Interior Evaluation : <b>C</b> | Exterior Evaluation : <b>E</b> |
|---|---|
| <p><b>Remarks</b></p> <p>Ceiling - Grime - Medium / Overall Interior - Worn as per age - Yes / (R) Front Floor Mat - Missing - Yes / (L) Front Floor Mat - Missing - Yes / Mat Other - Missing - Yes</p> | <p><b>Remarks</b></p> <p>Trunk Hood, Rear Gate - Repair Traces - Yes / (R) Rear Fender - Repair Traces - Yes / (R) Center Panel - Repair Traces - Yes / (R) Front Fender, Molding - Scratch - Small / (R) Front Door, Molding - Scratch - Medium / (R) Center Panel - Scratch - Small / (R) Rear Door, Molding - Scratch - Small / (R) Rear Fender, Molding - Scratch - Minimal / Rear Bumper, Lamps, Panels - Scratch - Small / Trunk Hood, Rear Gate - Dent - Medium / (L) Rear Fender, Molding - Scratch - Minimal / (L) Rear Door, Molding - Scratch &amp; Dent - Medium / (L) Front Door, Molding - Scratch - Small / (L) Mirror - Scratch - Small / (L) Front Fender, Molding - Scratch - Small / Front Bumper, Grille, Lamps - Modified - Large / Front Bumper, Grille, Lamps - Scratch - Medium / Rear Bumper, Lamps, Panels - Modified - Large / Bonnet, Headlight - Dent - Small / Roof - Dent - Medium / (R) Mirror - Scratch - Minimal</p> |

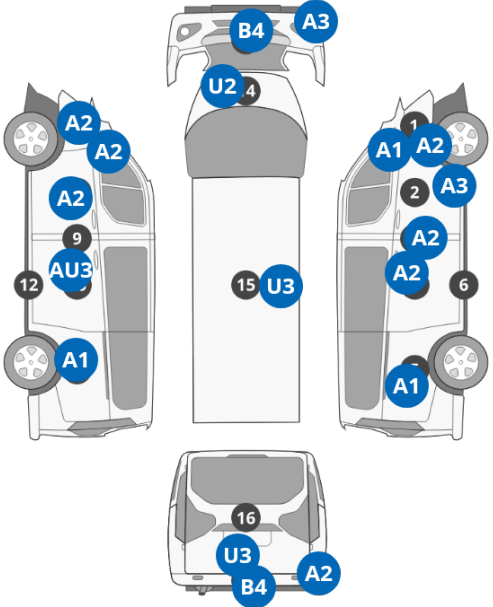
with warranty booklet, with jack, no tools, with spare tire, with LTO plate, scratches on headlight and taillight, yellowish headlight, power window button on driver side issue, many touch up panel
