## General Information

| Make | Toyota | Model | Wigo |
| YOM | 2021 | Odo Meter Reading | 61,403 |
| Registration No. | DAV2874 | Chassis No. | MHKA4DF5MJ054773 |

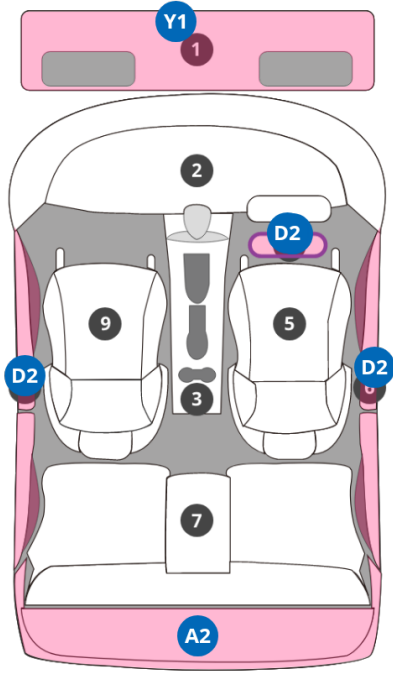
| Interior Evaluation : <b>B</b> | Exterior Evaluation : <b>C</b> |
| <p><b>Remarks</b></p> <p>Mat Other - Missing - Yes / Trunk Room - Worn, Scratch, Cut, Crack - Small / (L) Front Floor Mat - Worked - Small / (L) Front Trim - Worked - Small / (R) Front Trim - Worked - Small / Ceiling - Grime - Minimal</p> | <p><b>Remarks</b></p> <p>(L) Front Door - Repair Traces - Yes / (R) Front Fender, Molding - Scratch - Small / (L) Front Door, Molding - Repair mark - Yes / (R) Mirror - Scratch - Small / (R) Step, In-panel, Side Spoiler - Scratch &amp; Dent - Medium / (R) Front Door, Molding - Scratch - Minimal / (R) Rear Door, Molding - Scratch - Minimal / (R) Rear Fender, Molding - Scratch - Minimal / Rear Bumper, Lamps, Panels - Scratch - Small / Trunk Hood, Rear Gate - Scratch - Minimal / (L) Rear Fender, Molding - Scratch - Minimal / (L) Front Fender, Molding - Scratch - Minimal / (L) Rear Door, Molding - Scratch - Minimal / Roof - Scratch - Small / (L) Mirror - Scratch - Minimal / (L) Front Door, Molding - Scratch - Minimal / Bonnet, Headlight - Scratch - Small / Front Bumper, Grille, Lamps - Scratch - Medium</p> |
