## General Information

| Make | Toyota | Model | Vios |
| Registration No. | NHM6266 | Chassis No. | PA1B18F39R4242057 |

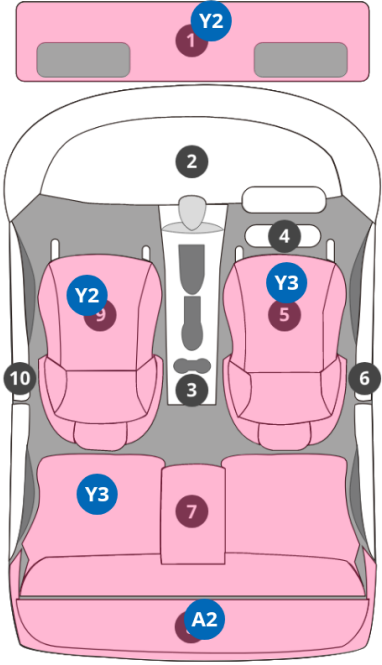
| Interior Evaluation : <b>B</b> | Exterior Evaluation : <b>D</b> |
|---|---|
| <b>Remarks</b><br>(R) Front Seat - Grime - Medium / Trunk Room - Worn, Scratch, Cut, Crack - Small / Rear Seat - Grime - Medium / Ceiling - Grime - Small / (L) Front Seat - Grime - Small | <b>Remarks</b><br>Trunk Hood, Rear Gate - Repair Traces - Yes / (R) Front Fender, Molding - Scratch - Minimal / (R) Front Door, Molding - Scratch - Small / (R) Mirror - Scratch - Minimal / (R) Step, In-panel, Side Spoiler - Scratch & Dent - Medium / (R) Rear Door, Molding - Scratch - Medium / (R) Rear Fender, Molding - Scratch - Medium / Rear Bumper, Lamps, Panels - Repair mark - Yes / Trunk Hood, Rear Gate - Repair mark - Yes / Rear Bumper, Lamps, Panels - Scratch - Medium / (L) Rear Fender, Molding - Scratch - Minimal / (L) Front Door, Molding - Dent - Small / (L) Rear Door, Molding - Scratch - Small / Roof - Scratch - Minimal / (L) Front Fender, Molding - Scratch - Minimal / Front Bumper, Grille, Lamps - Scratch - Medium / Bonnet, Headlight - Scratch - Minimal |
