## General Information

| Make | Toyota | Model | Vios |

## Body / Panel Condition

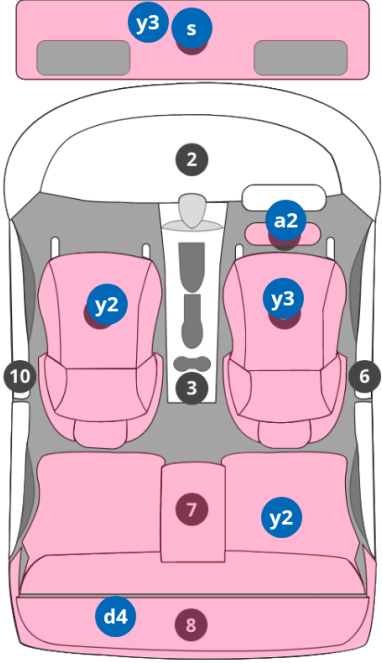
| <p><b>Remarks</b><br/>Overall Interior - Smell - Yes / (L) Front Floor Lag - Cut, Crack - Small / (L) Front Seat - Grime - Small / Ceiling - Grime - Medium / Trunk Room - Loose, Deformed, Grime - Large / Rear Seat - Grime - Small / (R) Front Seat - Grime - Medium</p> | <p><b>Remarks</b><br/>(R) Front Door, Molding - Scratch &amp; Dent - Minimal / Rear Bumper, Lamps, Panels - Scratch - Minimal / (L) Rear Door, Molding - Scratch - Small</p> |

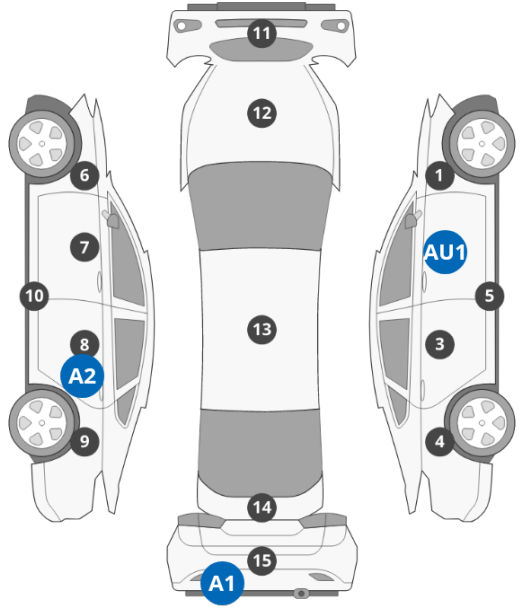
| Inspector Notes |
|---|
| light scratches around the exterior. |
