## General Information

| Make | Toyota | Model | Wigo |
| YOM | 2021 | Odo Meter Reading | 55,692 |
| Registration No. | GAT5259 | Chassis No. | MHKA4DF5FMJ053864 |

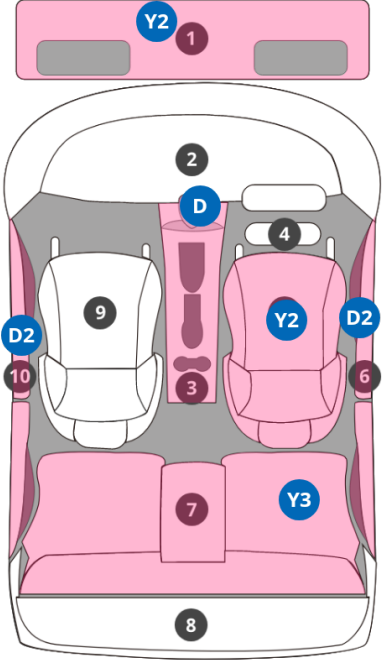
| <b>Remarks</b><br>Rear Seat - Grime - Medium / (R) Front Seat - Grime - Small / (R) Front Trim - Worked - Small / (L) Front Trim - Worked - Small / Console, Switchs, Vents - Traces of Adhesive Tape - Yes / Ceiling - Grime - Small / Overall Interior - Worn as per age - Yes | <b>Remarks</b><br>Bonnet - Repair Traces - Yes / (R) Mirror - Scratch - Minimal / (R) Front Door, Molding - Scratch - Minimal / (R) Rear Door, Molding - Scratch - Minimal / Rear Bumper, Lamps, Panels - Scratch - Small / (L) Rear Door, Molding - Scratch - Minimal / (L) Front Door, Molding - Scratch - Minimal / (L) Mirror - Scratch - Minimal / Front Bumper, Grille, Lamps - Scratch - Minimal |

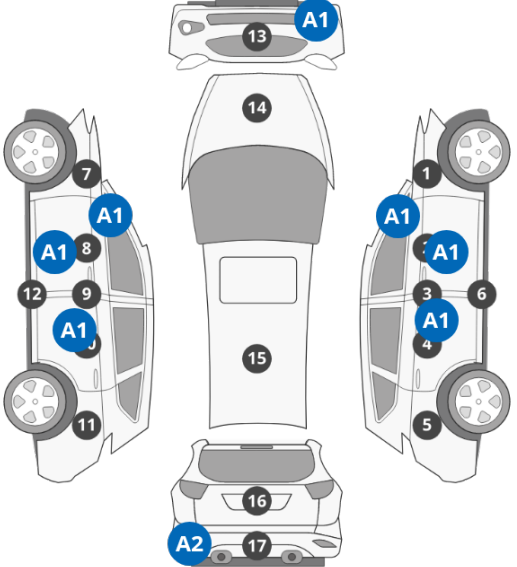
| no warranty booklet, with jack and tools, with spare tire, with LTO plate, scratches on tail light |
