## General Information

| Make | Toyota | Model | Innova |
| Registration No. | NHA4694 | Chassis No. | PA2JA8EM4P0133673 |

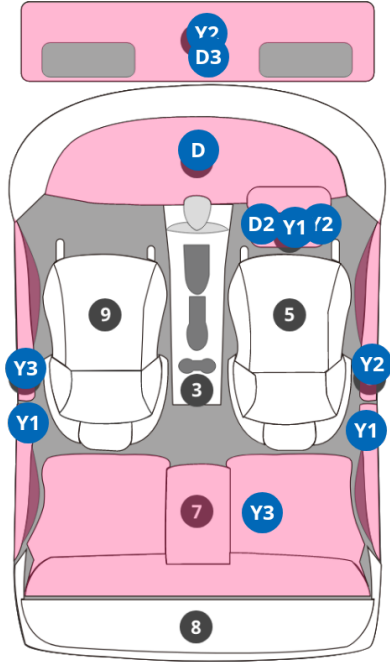
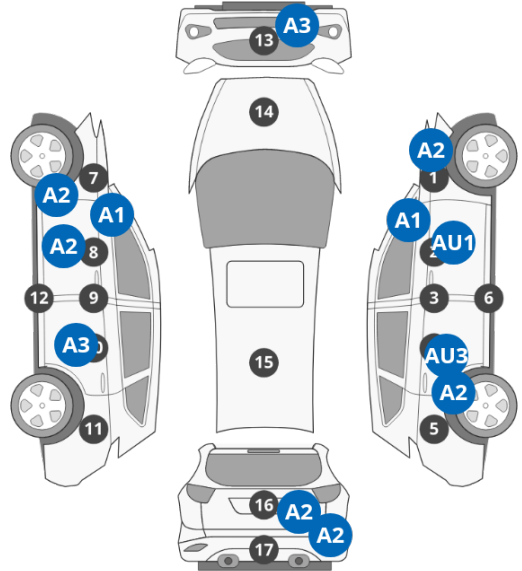
| Interior Evaluation : <span style="color: red;">C</span> | Exterior Evaluation : <span style="color: red;">C</span> |
|---|---|
| <p><b>a</b> : Cut, Fray <b>d</b> : Loose, Deformed <b>k</b> : Animal Hair <b>s</b> : Smell <b>t</b> : Cigarette Burns <b>x</b> : Defective <b>y</b> : Stain</p> | <p><b>A</b> : Scratch <b>AU</b> : Scratch &amp; Dent <b>B</b> : Modified <b>C</b> : Corrosion <b>G</b> : Stone chip <b>P</b> : Faded <b>S</b> : Rust <b>SC</b> : Rust &amp; Corrosion <b>U</b> : Dent <b>X</b> : Defective <b>Y</b> : Crack, Gap</p> |
| <b>Remarks</b><br>Ceiling - Grime - Small / (R) Front Trim - Grime - Small / (R) Front Floor Mat - Grime - Small / Dashboard - Traces of Adhesive Tape - Yes / Rear Seat - Grime - Medium / Mat Other - Grime - Minimal / (R) Rear Trim - Grime - Minimal / (L) Rear Trim - Grime - Minimal / (L) Front Trim - Grime - Medium / (L) Front Floor Mat - Worked - Small / Sunvisor, Sunglass Holder - Loose, Deformed - Medium | <b>Remarks</b><br>(R) Mirror - Scratch - Minimal / (L) Mirror - Scratch - Minimal / (L) Rear Door, Molding - Scratch - Medium / (R) Front Fender, Molding - Scratch - Small / (R) Front Door, Molding - Scratch & Dent - Minimal / (R) Rear Door, Molding - Scratch & Dent - Medium / (R) Rear Fender, Molding - Scratch - Small / Rear Bumper, Lamps, Panels - Scratch - Small / Trunk Hood, Rear Gate - Scratch - Small / (L) Front Door, Molding - Scratch - Small / (L) Front Fender, Molding - Scratch - Small / Front Bumper, Grille, Lamps - Scratch - Medium |
