## General Information

| Make | Toyota | Model | Raize |
| YOM | 2023 | Odo Meter Reading | 28,376 |

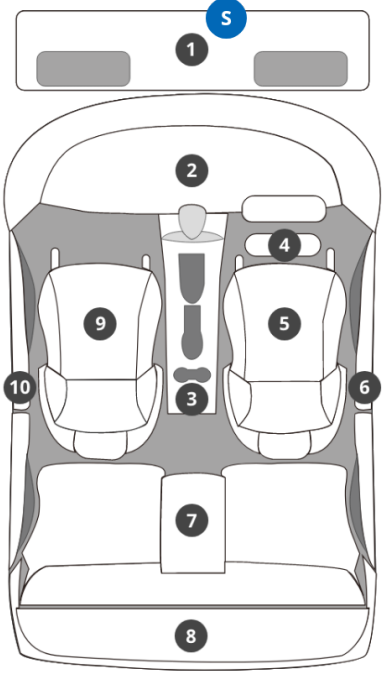
| <b>Interior Evaluation :</b> <span style="color: red; font-weight: bold;">B</span> | <b>Exterior Evaluation :</b> <span style="color: red; font-weight: bold;">B</span> |
| <b>Remarks</b><br>Overall Interior - Smell - Yes | <b>Remarks</b><br>Bonnet - Repair Traces - Yes / Trunk Hood, Rear Gate - Scratch - Small / Front Bumper, Grille, Lamps - Scratch - Small / (R) Front Door, Molding - Scratch & Dent - Minimal / (R) Rear Door, Molding - Scratch - Minimal / Rear Bumper, Lamps, Panels - Scratch - Small / (L) Rear Door, Molding - Scratch & Dent - Small / (L) Front Door, Molding - Scratch - Minimal / (L) Front Fender, Molding - Scratch - Minimal / (L) Rear Fender, Molding - Scratch - Small / (R) Rear Fender, Molding - Scratch - Minimal / Roof - Scratch - Minimal / Bonnet, Headlight - Scratch - Minimal / (R) Front Fender, Molding - Scratch - Minimal |
