## General Information

| Make | Suzuki | Model | Dzire |

## Body / Panel Condition

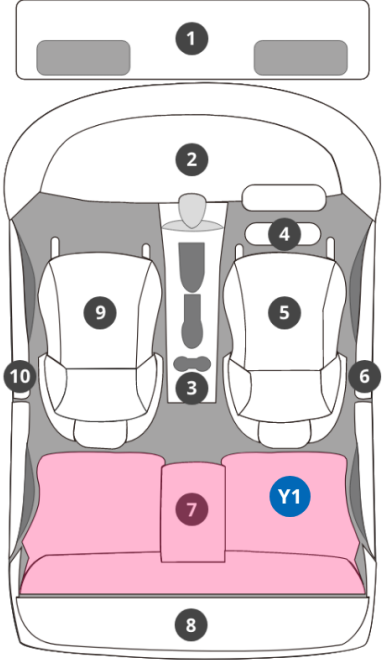
| Interior Evaluation : <b>A</b> | Exterior Evaluation : <b>B</b> |
| <b>Remarks</b><br>Rear Seat - Grime - Minimal | <b>Remarks</b><br>(R) Front Fender, Molding - Scratch - Minimal / (R) Front Door, Molding - Scratch - Minimal / (R) Rear Door, Molding - Scratch - Small / (R) Rear Fender, Molding - Scratch - Minimal / Rear Bumper, Lamps, Panels - Scratch - Small / Trunk Hood, Rear Gate - Scratch - Small / Roof - Scratch - Minimal / (L) Rear Fender, Molding - Scratch - Minimal / (L) Front Door, Molding - Scratch - Minimal / (L) Rear Door, Molding - Scratch - Minimal / (L) Front Fender, Molding - Scratch & Dent - Minimal / Bonnet, Headlight - Scratch - Small / Front Bumper, Grille, Lamps - Scratch - Small / (R) Mirror - Scratch - Minimal / (L) Mirror - Scratch - Minimal |
