## General Information

| Make | Toyota | Model | Vios |

## Body / Panel Condition

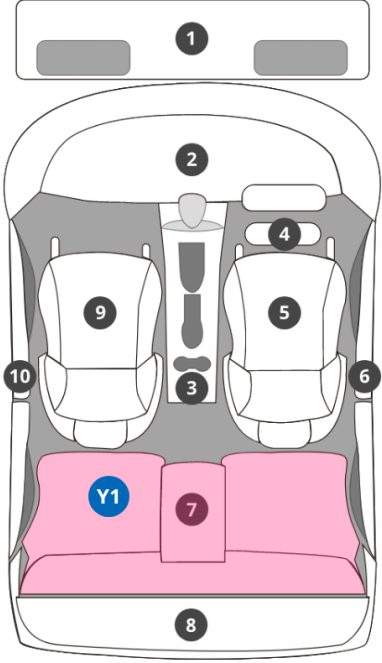
| Interior Evaluation : <b>A</b> | Exterior Evaluation : <b>B</b> |
| <b>Remarks</b><br>Rear Seat - Grime - Minimal | <b>Remarks</b><br>(R) Mirror - Scratch - Minimal / (R) Front Door, Molding - Scratch - Minimal / (R) Rear Door, Molding - Scratch - Minimal / Roof - Scratch - Minimal / Rear Bumper, Lamps, Panels - Scratch - Minimal / Trunk Hood, Rear Gate - Scratch - Minimal / (L) Rear Fender, Molding - Scratch - Minimal / (L) Rear Door, Molding - Scratch - Medium / (L) Front Door, Molding - Scratch - Small / (L) Front Fender, Molding - Scratch - Minimal / Front Bumper, Grille, Lamps - Scratch - Small / Bonnet, Headlight - Dent - Small |
