## General Information

| Make | Toyota | Model | Vios |
| YOM | 2024 | Odo Meter Reading | 26,865 |
| Registration No. | NHG3118 | Chassis No. | PA1B18F3XP4227788 |

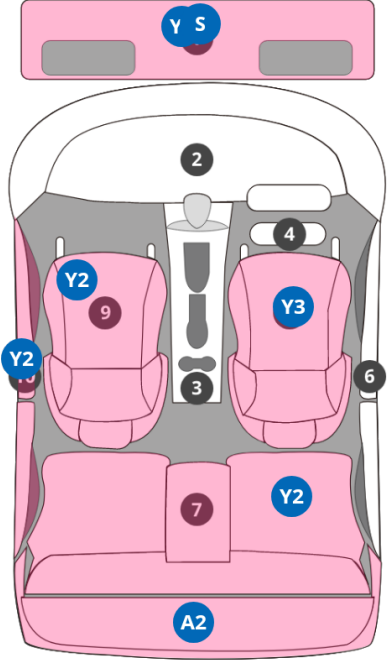
| <b>Remarks</b><br>(R) Front Seat - Grime - Medium / Trunk Room - Worn, Scratch, Cut, Crack - Small / Rear Seat - Grime - Small / Ceiling - Grime - Minimal / (L) Front Trim - Grime - Small / (L) Front Seat - Grime - Small / Overall Interior - Smell - Yes | <b>Remarks</b><br>(R) Front Fender, Molding - Scratch - Small / (R) Mirror - Scratch - Small / (R) Step, In-panel, Side Spoiler - Dent - Medium / (R) Front Door, Molding - Scratch - Minimal / (R) Rear Door, Molding - Scratch - Minimal / (R) Rear Fender, Molding - Scratch - Small / Rear Bumper, Lamps, Panels - Scratch - Small / Trunk Hood, Rear Gate - Scratch & Dent - Small / Roof - Scratch - Small / (L) Rear Fender, Molding - Scratch - Small / (L) Rear Door, Molding - Scratch - Large / (L) Front Door, Molding - Scratch - Small / (L) Step, In-panel, Side Spoiler - Dent - Small / (L) Mirror - Scratch - Minimal / (L) Front Fender, Molding - Scratch - Minimal / Front Bumper, Grille, Lamps - Scratch - Small / Bonnet, Headlight - Scratch - Small |
