## General Information

| Make | Toyota | Model | Vios |
| YOM | 2022 | Odo Meter Reading | 69,841 |
| Registration No. | NEM9818 | Chassis No. | PA1B18F37M4164807 |

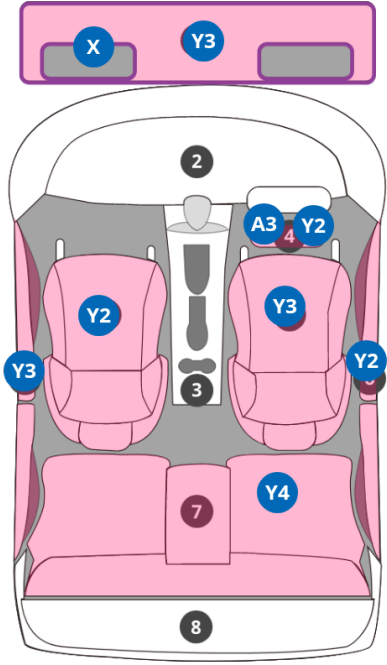
| Interior Evaluation : <span style="color: red;">C</span> | Exterior Evaluation : <span style="color: red;">E</span> |
|---|---|
| <p><b>Remarks</b></p> <p>Ceiling - Grime - Medium / (R) Front Trim - Grime - Small / (R) Front Seat - Grime - Medium / (R) Front Floor Mat - Grime - Small / Rear Seat - Grime - Large / (L) Front Trim - Grime - Medium / (L) Front Floor Mat - Cut, Crack - Medium / (L) Front Seat - Grime - Small / Sunvisor, Sunglass Holder - Missing - Yes</p> | <p><b>Remarks</b></p> <p>Bonnet - Repair Traces - Yes / Trunk Hood, Rear Gate - Scratch &amp; Dent - Large / Rear Bumper, Lamps, Panels - Scratch - Large / (L) Rear Fender, Molding - Scratch &amp; Dent - Large / (L) Rear Door, Molding - Scratch - Large / (L) Front Door, Molding - Scratch &amp; Dent - Large / (L) Front Fender, Molding - Scratch &amp; Dent - Medium / Front Bumper, Grille, Lamps - Repair mark - Yes / Front Bumper, Grille, Lamps - Scratch &amp; Dent - Large / (R) Front Fender, Molding - Scratch &amp; Dent - Large / (R) Mirror - Scratch - Small / (R) Front Door, Molding - Scratch - Small / (R) Rear Door, Molding - Scratch &amp; Dent - Small / (R) Rear Fender, Molding - Scratch - Minimal / Roof - Dent - Minimal / Bonnet, Headlight - Scratch - Medium</p> |

| Inspector Notes |
|---|
| <p>Crack taillight. Reverse light missing. Left headlight lowbeam issue. Left sunvisor missing. Without warranty booklet,jack,tools, and seat cover. With spare tire. 1 key. With LTO plate. Adhesive marks rear view mirror.</p> |
