## General Information

| Make | Suzuki | Model | S-Presso |

## Body / Panel Condition

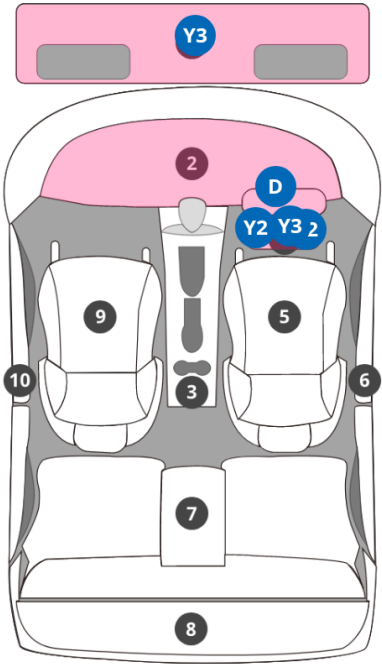
| <b>Remarks</b><br>Ceiling - Grime - Medium / Dashboard - Traces of Adhesive Tape - Yes / (R) Front Floor Mat - Grime - Small / Mat Other - Grime - Medium / (L) Front Floor Mat - Grime - Small | <b>Remarks</b><br>Front Bumper, Grille, Lamps - Scratch & Dent - Large / (R) Front Fender, Molding - Scratch - Small / (R) Mirror - Scratch - Medium / (R) Rear Door, Molding - Scratch - Medium / (R) Step, In-panel, Side Spoiler - Scratch & Dent - Medium / (R) Rear Fender, Molding - Scratch & Dent - Small / Rear Bumper, Lamps, Panels - Scratch & Dent - Large / Trunk Hood, Rear Gate - Scratch & Dent - Small / (L) Rear Fender, Molding - Scratch - Small / (L) Rear Door, Molding - Scratch & Dent - Medium / (L) Front Door, Molding - Scratch - Large / (L) Mirror - Scratch - Small / (L) Front Fender, Molding - Scratch - Medium |

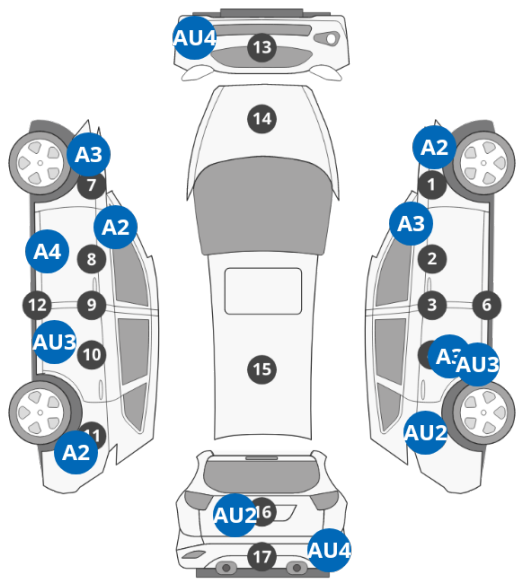
| Gap at front bumper. With warranty booklet, spare tire, jack and tools. 1 key. With LTO plate. |
