## General Information

| Make | Toyota | Model | Hilux |

## Body / Panel Condition

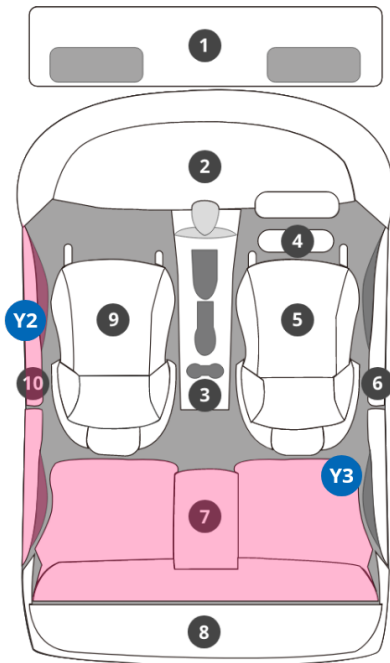
| Interior Evaluation : <b>B</b> | Exterior Evaluation : <b>C</b> |
|---|---|
| <b>Remarks</b><br>Rear Seat - Grime - Medium / (L) Front Trim - Grime - Small | <b>Remarks</b><br>(R) Front Fender, Molding - Scratch - Small / (R) Front Door, Molding - Scratch - Minimal / (R) Rear Door, Molding - Scratch - Small / (R) Side Gate - Scratch - Medium / Rear Gate - Scratch & Dent - Small / (L) Side Gate - Scratch - Small / (L) Rear Door, Molding - Scratch - Small / (L) Front Door, Molding - Scratch - Small / Front Bumper, Grille, Lamps - Scratch - Small / Bonnet, Headlight - Scratch - Minimal |

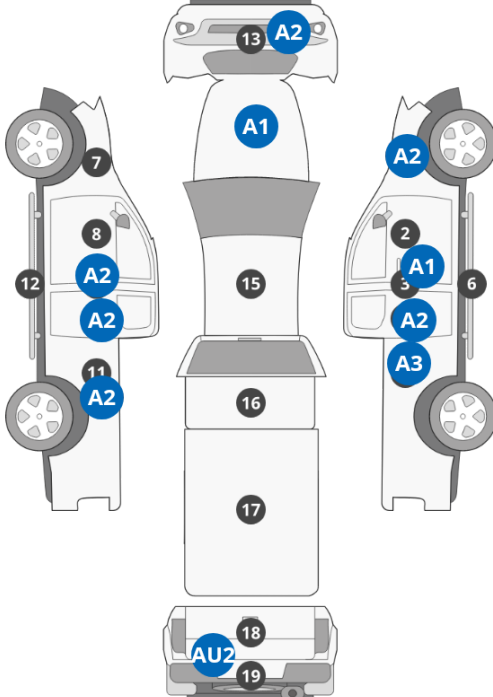
no warranty booklet, with jack and tools, with spare tire, with LTO plate, scratches on tail light
