## General Information

| Make | Toyota | Model | Vios |
| Registration No. | DBM8685 | Chassis No. | PA1B18F33R4246329 |

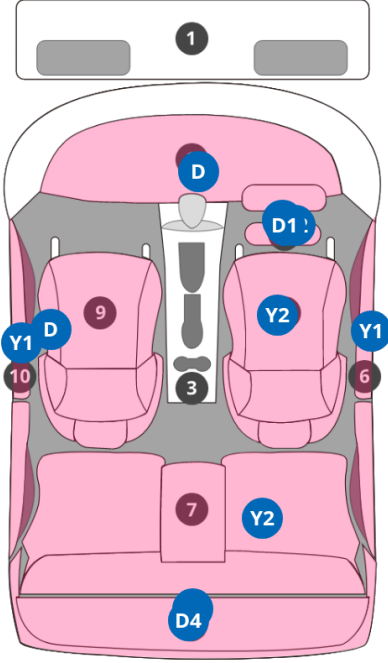
| Interior Evaluation : <b>C</b> | Exterior Evaluation : <b>D</b> |
| <p><b>Remarks</b></p> <p>Overall Interior - Smell - Yes / Trunk Room - Loose, Deformed - Large / (R) Front Trim - Grime - Minimal / (L) Front Floor Mat - Cut, Crack - Small / (L) Front Floor Mat - Worked - Small / (L) Front Trim - Grime - Minimal / Carpet - Worked - Minimal / Dashboard - Traces of Adhesive Tape - Yes / (R) Front Seat - Grime - Small / (L) Front Seat - Worn - Yes / Rear Seat - Grime - Small</p> | <p><b>Remarks</b></p> <p>(R) Front Fender, Molding - Scratch - Medium / (R) Mirror - Scratch - Minimal / (R) Front Door, Molding - Scratch &amp; Dent - Medium / (R) Rear Door, Molding - Scratch - Medium / (R) Rear Fender, Molding - Scratch - Small / Rear Bumper, Lamps, Panels - Scratch - Medium / Trunk Hood, Rear Gate - Scratch - Small / (L) Rear Door, Molding - Scratch &amp; Dent - Medium / (L) Mirror - Scratch - Small / (L) Step, In-panel, Side Spoiler - Scratch - Small / Front Bumper, Grille, Lamps - Scratch - Medium / Bonnet, Headlight - Scratch - Minimal / (L) Front Door, Molding - Scratch - Minimal / (L) Rear Fender, Molding - Scratch - Minimal</p> |
