## General Information

| Make | Toyota | Model | Vios |

## Body / Panel Condition

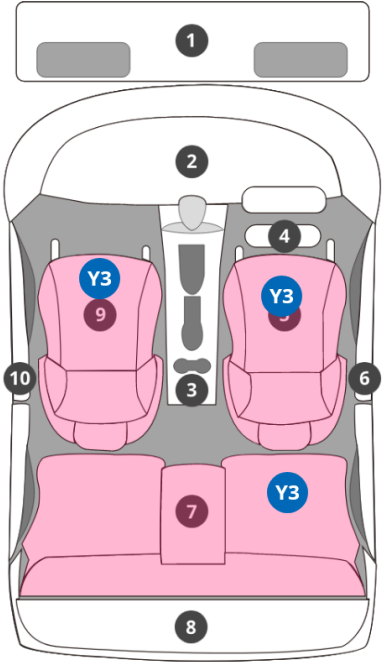
| Interior Evaluation : <b>B</b> | Exterior Evaluation : <b>C</b> |
|---|---|
| <b>Remarks</b><br>(R) Front Seat - Grime - Medium / (L) Front Seat - Grime - Medium / Rear Seat - Grime - Medium | <b>Remarks</b><br>(R) Rear Door, Molding - Scratch & Dent - Small / (R) Rear Fender, Molding - Scratch - Minimal / (R) Front Door, Molding - Scratch & Dent - Minimal / (R) Front Fender, Molding - Dent - Minimal / Trunk Hood, Rear Gate - Scratch - Small / Bonnet, Headlight - Scratch & Dent - Small / (L) Rear Door, Molding - Scratch - Medium / (L) Front Door, Molding - Scratch - Medium / (L) Rear Fender, Molding - Scratch - Small / Rear Bumper, Lamps, Panels - Scratch - Minimal / Roof - Scratch - Minimal / Front Bumper, Grille, Lamps - Scratch & Dent - Small |

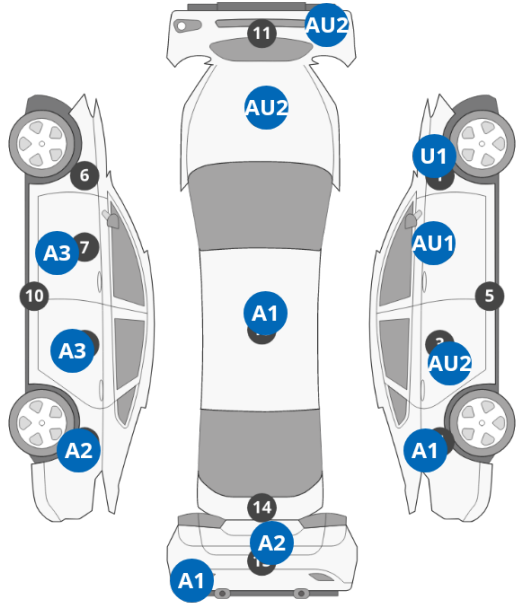
with LTO plate and Jack, Sparetire and incomplete tools. no warranty booklet and scratch tail lights and head lights.
