## General Information

| Make | Mitsubishi | Model | Xpander |

## Body / Panel Condition

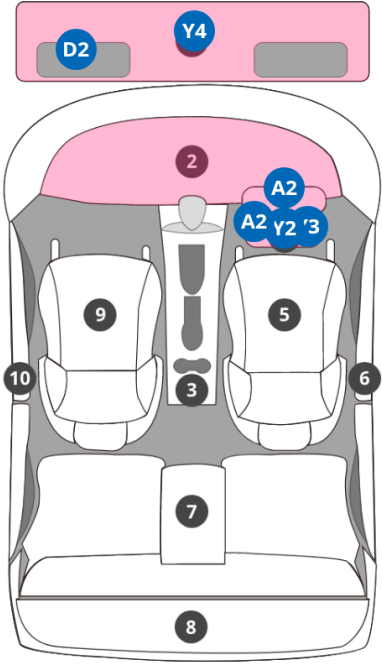
| Interior Evaluation : <span style="color: red;">C</span> | Exterior Evaluation : <span style="color: red;">C</span> |
| <b>Remarks</b><br>Ceiling - Grime - Large / (R) Front Floor Mat - Grime - Medium / Mat Other - Grime - Small / (L) Front Floor Mat - Cut, Crack - Small / Sunvisor, Sunglass Holder - Crinkle - Small / Steering Wheel - Worn, Peel, Crack - Small | <b>Remarks</b><br>Trunk Hood, Rear Gate - Repair Traces - Yes / (L) Mirror - Scratch - Minimal / (L) Front Door, Molding - Scratch & Dent - Small / (L) Rear Door, Molding - Scratch & Dent - Medium / (L) Rear Fender, Molding - Scratch & Dent - Minimal / (L) Front Fender, Molding - Scratch & Dent - Small / (R) Mirror - Scratch - Small / Front Bumper, Grille, Lamps - Scratch - Medium / Bonnet, Headlight - Dent - Small / (R) Front Door, Molding - Scratch - Small / (R) Rear Door, Molding - Scratch - Small / (R) Rear Fender, Molding - Scratch & Dent - Small / Rear Bumper, Lamps, Panels - Scratch & Dent - Small |
