## General Information

| Make | Mitsubishi | Model | Mirage |
| YOM | 2019 | Odo Meter Reading | 51,732 |

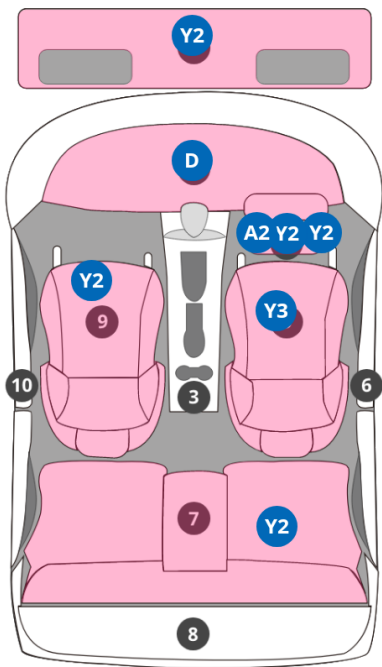
| <div> <div>Interior Evaluation :</div> <div>B</div> </div> | <div> <div>Exterior Evaluation :</div> <div>E</div> </div> |
| <div> <div>Remarks</div> <div>Ceiling - Grime - Small / (R) Front Seat - Grime - Medium / (R) Front Floor Mat - Grime - Small / Dashboard - Traces of Adhesive Tape - Yes / Rear Seat - Grime - Small / Mat Other - Grime - Small / (L) Front Floor Mat - Cut, Crack - Small / (L) Front Seat - Grime - Small</div> </div> | <div> <div>Remarks</div> <div>(R) Front Fender - Repair Traces - Yes / Bonnet - Repair Traces - Yes / (L) Front Fender - Repair Traces - Yes / (L) Front Door - Repair Traces - Yes / (L) Rear Door - Repair Traces - Yes / (L) Rear Fender - Repair Traces - Yes / Trunk Hood, Rear Gate - Repair Traces - Yes / (R) Rear Fender - Repair Traces - Yes / Roof - Repair Traces - Yes / (L) Mirror - Scratch - Minimal / Front Bumper, Grille, Lamps - Scratch &amp; Dent - Large / Bonnet, Headlight - Scratch - Small / (R) Mirror - Scratch - Small / (R) Front Fender, Molding - Scratch - Small / (R) Rear Door, Molding - Scratch &amp; Dent - Large / (R) Front Door, Molding - Scratch - Small / (R) Rear Fender, Molding - Scratch - Small / Rear Bumper, Lamps, Panels - Scratch &amp; Dent - Small / Trunk Hood, Rear Gate - Scratch - Large / (L) Rear Door, Molding - Scratch - Small / (L) Front Door, Molding - Scratch - Small / Roof - Scratch - Small / (L) Front Fender, Molding - Scratch - Small</div> </div> |
