## General Information

| Make | Ford | Model | Explorer |
| YOM | 2018 | Odo Meter Reading | 63,016 |
| Registration No. | NBF7713 | Chassis No. | 1FM5K8GT4JGA93723 |

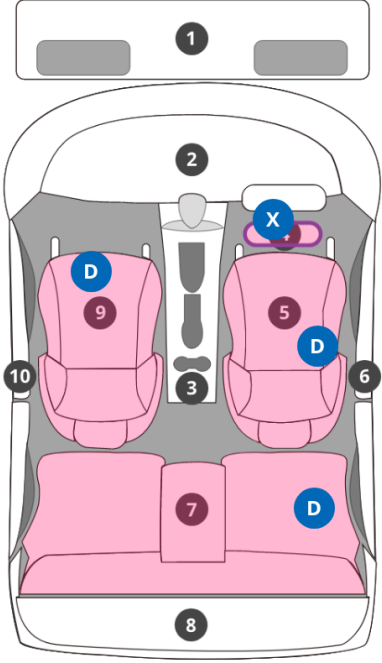
| Interior Evaluation : <b>B</b> | Exterior Evaluation : <b>C</b> |
|---|---|
| <b>Remarks</b><br>Rear Seat - Worn - Yes / Mat Other - Missing - Yes / (R)<br>Front Seat - Worn - Yes / (L) Front Seat - Worn - Yes | <b>Remarks</b><br>(L) Rear Door - Repair Traces - Yes / (R) Front Fender, Molding - Scratch - Small / (R) Mirror - Scratch - Minimal / (R) Front Door, Molding - Dent - Small / (R) Rear Door, Molding - Scratch & Dent - Small / (R) Rear Fender, Molding - Scratch - Minimal / Rear Bumper, Lamps, Panels - Scratch - Small / Trunk Hood, Rear Gate - Scratch - Small / (L) Rear Fender, Molding - Scratch & Dent - Minimal / (L) Rear Door, Molding - Scratch - Medium / (L) Mirror - Scratch - Small / (L) Front Door, Molding - Scratch & Dent - Small / (L) Front Fender, Molding - Scratch - Small / Front Bumper, Grille, Lamps - Scratch - Minimal |
