## General Information

| Make | Nissan | Model | Navara |
| YOM | 2022 | Odo Meter Reading | 80,869 |
| Registration No. | BAC5645 | Chassis No. | MNTCCAD23Z0010484 |

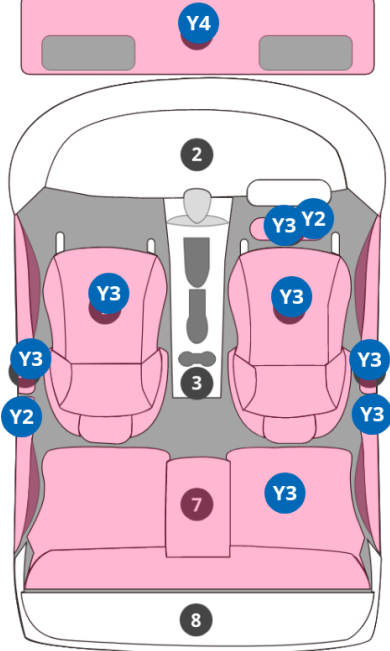
| Interior Evaluation : <b>E</b> | Exterior Evaluation : <b>C</b> |
|---|---|
| <p><b>Remarks</b></p> <p>Ceiling - Grime - Large / (R) Front Trim - Grime - Medium / (R) Front Floor Mat - Grime - Small / (R) Front Seat - Grime - Medium / (R) Rear Trim - Grime - Medium / Rear Seat - Grime - Medium / Mat Other - Grime - Medium / (L) Rear Trim - Grime - Small / (L) Front Trim - Grime - Medium / (L) Front Seat - Grime - Medium</p> | <p><b>Remarks</b></p> <p>Bonnet, Headlight - Dent - Small / Front Bumper, Grille, Lamps - Scratch &amp; Dent - Medium / (L) Front Fender, Molding - Scratch &amp; Dent - Small / (L) Rear Door, Molding - Scratch - Small / (L) Step, In-panel, Side Spoiler - Partially Missing - Yes / (L) Side Gate - Scratch - Minimal / Rear Bumper, Lamps, Panels - Scratch &amp; Dent - Medium / Rear Gate - Scratch &amp; Dent - Medium / (R) Side Gate - Scratch - Minimal / (R) Front Door, Molding - Scratch - Small / (R) Mirror - Scratch - Minimal / (R) Front Fender, Molding - Scratch - Small / (L) Front Door, Molding - Scratch - Minimal / Cab Back Panel - Scratch - Minimal</p> |
