## General Information

| Make | Toyota | Model | Vios |

## Body / Panel Condition

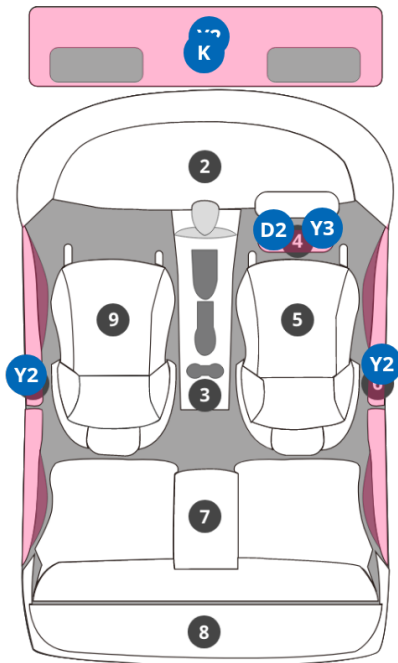
| <b>Remarks</b><br>Ceiling - Grime - Small / (R) Front Trim - Grime - Small / (R) Front Floor Mat - Grime - Medium / Overall Interior - Animal Hair - Yes / (L) Front Trim - Grime - Small / (L) Front Floor Mat - Worked - Small | <b>Remarks</b><br>(R) Front Fender - Repair Traces - Yes / Trunk Hood, Rear Gate - Repair Traces - Yes / (R) Rear Fender - Repair Traces - Yes / (R) Rear Door - Repair Traces - Yes / (L) Front Fender, Molding - Scratch & Dent - Small / (L) Front Door, Molding - Scratch & Dent - Minimal / (L) Rear Door, Molding - Scratch - Small / (L) Rear Fender, Molding - Scratch - Minimal / (R) Mirror - Scratch - Minimal / (R) Rear Door, Molding - Scratch - Minimal / (R) Front Door, Molding - Scratch & Dent - Small / Front Bumper, Grille, Lamps - Scratch - Medium / Rear Bumper, Lamps, Panels - Scratch - Minimal |
