## General Information

| Make | Toyota | Model | Vios |
| Registration No. | NFC9871 | Chassis No. | PA1B18F3XP4221733 |

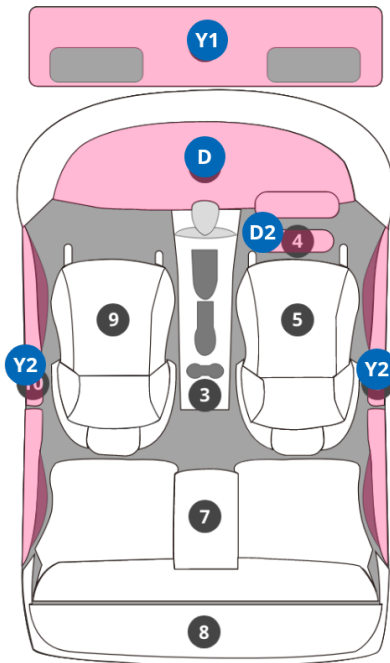
| Interior Evaluation : <b>B</b> | Exterior Evaluation : <b>C</b> |
|---|---|
| <p><b>Remarks</b></p> <p>Ceiling - Grime - Minimal / (R) Front Trim - Grime - Small / Dashboard - Traces of Adhesive Tape - Yes / (L) Front Trim - Grime - Small / (L) Front Floor Mat - Worked - Small</p> | <p><b>Remarks</b></p> <p>(L) Mirror - Scratch - Minimal / (L) Front Door, Molding - Scratch - Small / (L) Front Fender, Molding - Scratch - Small / Bonnet, Headlight - Scratch - Small / (R) Front Door, Molding - Scratch - Small / (R) Front Fender, Molding - Scratch - Minimal / Trunk Hood, Rear Gate - Scratch - Small / (R) Rear Fender, Molding - Dent - Minimal / (R) Rear Door, Molding - Scratch - Small / Rear Bumper, Lamps, Panels - Scratch - Small / (L) Rear Fender, Molding - Scratch - Small / (L) Rear Door, Molding - Scratch - Small / Front Bumper, Grille, Lamps - Scratch - Small</p> |
