## General Information

| Make | Toyota | Model | Vios |
| YOM | 2024 | Odo Meter Reading | 21,118 |
| Registration No. | IAF4603 | Chassis No. | PA1B18F3XR4251236 |

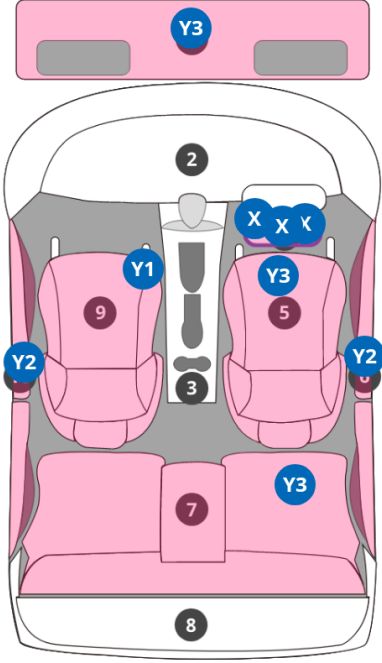
| Interior Evaluation : <b>B</b> | Exterior Evaluation : <b>B</b> |
| <p><b>Remarks</b><br/>Ceiling - Grime - Medium / (R) Front Floor Mat - Missing - Yes / Mat Other - Missing - Yes / (L) Front Floor Mat - Missing - Yes / (R) Front Trim - Grime - Small / (R) Front Seat - Grime - Medium / Rear Seat - Grime - Medium / (L) Front Trim - Grime - Small / (L) Front Seat - Grime - Minimal</p> | <p><b>Remarks</b><br/>(L) Mirror - Scratch - Minimal / Trunk Hood, Rear Gate - Scratch - Medium / (L) Front Door, Molding - Scratch - Minimal / Front Bumper, Grille, Lamps - Scratch - Medium</p> |
