## General Information

| Make | Toyota | Model | Vios |

## Body / Panel Condition

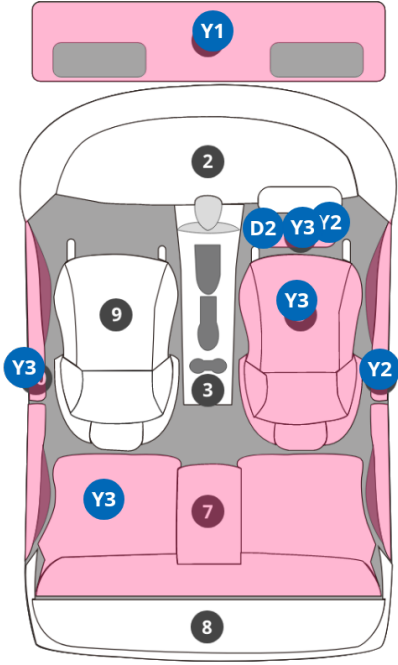
| Interior Evaluation : <span style="color: red;">C</span> | Exterior Evaluation : <span style="color: red;">C</span> |
|---|---|
| <p><b>Remarks</b><br/>Ceiling - Grime - Minimal / (R) Front Trim - Grime - Small / (R) Front Floor Mat - Grime - Small / (R) Front Seat - Grime - Medium / Rear Seat - Grime - Medium / Mat Other - Grime - Medium / (L) Front Trim - Grime - Medium / (L) Front Floor Mat - Worked - Small</p> | <p><b>Remarks</b><br/>(L) Front Door, Molding - Scratch - Minimal / (R) Front Fender, Molding - Scratch - Small / (R) Front Door, Molding - Scratch - Small / Rear Bumper, Lamps, Panels - Scratch &amp; Dent - Large / Roof - Scratch - Small / Front Bumper, Grille, Lamps - Scratch &amp; Dent - Minimal</p> |

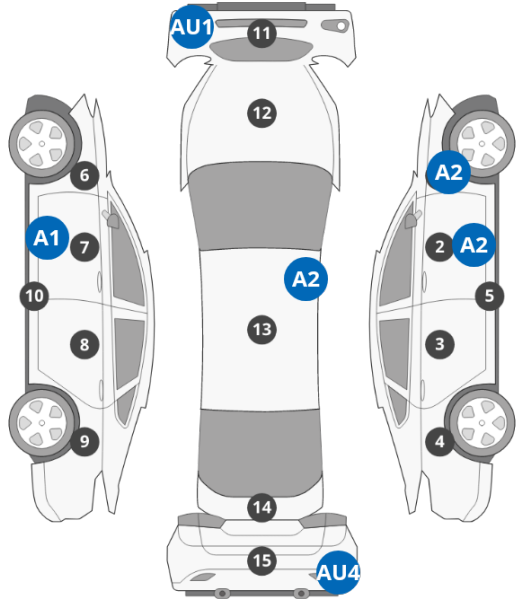
| Inspector Notes |
|---|
| Crack taillight, Without warranty booklet and seat cover. Incomplete tools. With spare tire and jack. 3 keys. With LTO plate. |
