## General Information

| Make | Toyota | Model | Hilux |
| YOM | 2022 | Odo Meter Reading | 134,697 |
| Registration No. | BAC3294 | Chassis No. | MR0JB8DD3M383765 |

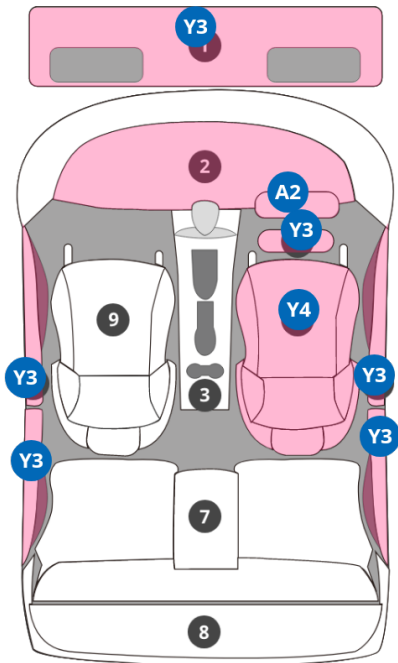
| Interior Evaluation : <b>D</b> | Exterior Evaluation : <b>E</b> |
| <p><b>Remarks</b></p> <p>(R) Front Trim - Grime - Medium / (R) Front Seat - Grime - Large / Ceiling - Grime - Medium / (R) Rear Trim - Grime - Medium / Mat Other - Grime - Medium / (L) Rear Trim - Grime - Medium / (L) Front Trim - Grime - Medium / Steering Wheel - Worn, Peel, Crack - Small</p> | <p><b>Remarks</b></p> <p>Cargo Bed Floor - Crack, Gap - Large / Rear Gate - Scratch - Medium / Rear Bumper, Lamps, Panels - Modified - Medium / (L) Side Gate - Scratch &amp; Dent - Large / Rear Bumper, Lamps, Panels - Scratch &amp; Dent - Medium / (R) Side Gate - Scratch - Medium / (R) Rear Door, Molding - Scratch - Small / (R) Rear Corner Panel - Scratch - Small / (R) Front Door, Molding - Scratch - Large / (R) Mirror - Scratch - Minimal / (L) Front Fender, Molding - Scratch - Medium / (L) Front Door, Molding - Scratch - Large / (L) Rear Door, Molding - Scratch - Medium / Front Bumper, Grille, Lamps - Scratch - Large / Front Windshield - Scratch, Stone chip - Small / (L) Side Gate - Modified - Large / (R) Side Gate - Modified - Large</p> |
