## General Information

| Make | Toyota | Model | Rush |
| YOM | 2022 | Odo Meter Reading | 62,326 |
| Registration No. | CAW7324 | Chassis No. | MHKR8FF3PMK037171 |

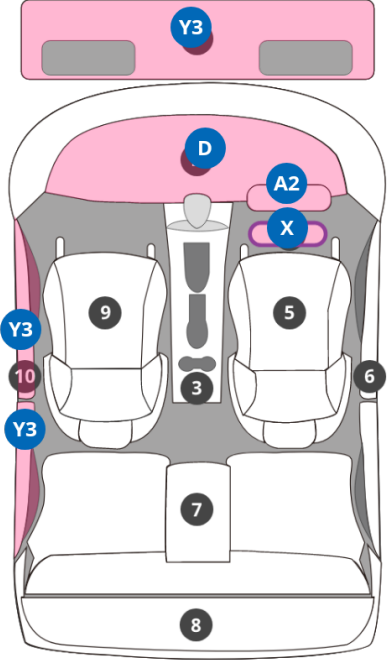
| <b>Interior Evaluation :</b> <span style="color: red; font-weight: bold;">B</span> | <b>Exterior Evaluation :</b> <span style="color: red; font-weight: bold;">C</span> |
| <p><b>Remarks</b><br/>Ceiling - Grime - Medium / Mat Other - Missing - Yes / (L) Rear Trim - Grime - Medium / (L) Front Trim - Grime - Medium / Steering Wheel - Worn, Peel, Crack - Small / Dashboard - Traces of Adhesive Tape - Yes</p> | <p><b>Remarks</b><br/>(L) Rear Fender, Molding - Scratch &amp; Dent - Small / (L) Front Fender, Molding - Dent - Minimal / (L) Rear Door, Molding - Scratch - Minimal / (L) Mirror - Scratch - Minimal / (L) Front Door, Molding - Scratch - Minimal / (R) Front Fender, Molding - Scratch - Medium / (R) Mirror - Scratch - Small / (R) Rear Door, Molding - Scratch - Minimal / (R) Rear Fender, Molding - Scratch - Minimal / Rear Bumper, Lamps, Panels - Scratch - Medium / Trunk Hood, Rear Gate - Scratch - Small / Front Bumper, Grille, Lamps - Scratch - Small</p> |
