## General Information

| Make | Toyota | Model | Vios |

## Body / Panel Condition

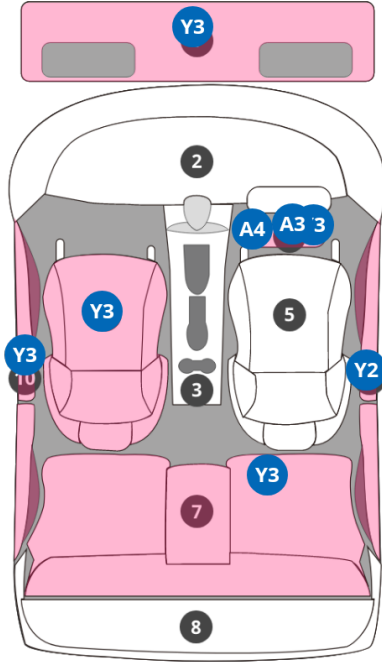
| Interior Evaluation : <b>D</b> | Exterior Evaluation : <b>E</b> |
| <p><b>Remarks</b></p> <p>Ceiling - Grime - Medium / (R) Front Trim - Grime - Small / (R) Front Floor Mat - Grime - Medium / Rear Seat - Grime - Medium / (L) Front Trim - Grime - Medium / (L) Front Seat - Grime - Medium / (L) Front Floor Mat - Cut, Crack - Large / Carpet - Worn, Scratch, Cut, Crack - Medium</p> | <p><b>Remarks</b></p> <p>(R) Rear Fender, Molding - Scratch &amp; Dent - Large / Rear Bumper, Lamps, Panels - Repair mark - Yes / Overall Exterior - Faded(Color, Gloss) - Yes / (R) Rear Door, Molding - Scratch &amp; Dent - Large / (R) Mirror - Scratch - Small / Trunk Hood, Rear Gate - Scratch &amp; Dent - Small / Rear Bumper, Lamps, Panels - Scratch &amp; Dent - Large / (L) Rear Door, Molding - Scratch &amp; Dent - Medium / (L) Step, In-panel, Side Spoiler - Scratch &amp; Dent - Small / (L) Mirror - Scratch - Small / (L) Front Fender, Molding - Scratch - Medium / Front Bumper, Grille, Lamps - Scratch - Medium / Roof - Scratch - Small / (R) Front Door, Molding - Scratch - Minimal / (L) Front Door, Molding - Scratch &amp; Dent - Minimal</p> |
