General Information

Make	Toyota	Model	Vios
YOM	2021	Odo Meter Reading	86,395
Registration No.	VAB1551	Chassis No.	PA1B18F32M4155318
CC	1.3	Transmission	M/T
Fuel Type	Gas	Type of Body	Sedan
Colour	Black

Body / Panel Condition

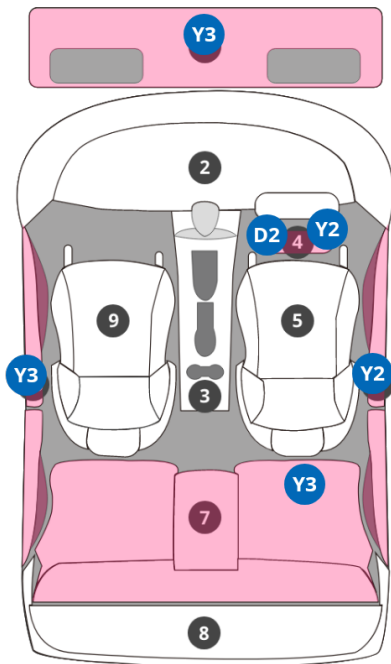
Interior Evaluation : B	Exterior Evaluation : D

<p>a : Cut, Fray d : Loose, Deformed k : Animal Hair s : Smell t : Cigarette Burns x : Defective y : Stain</p>

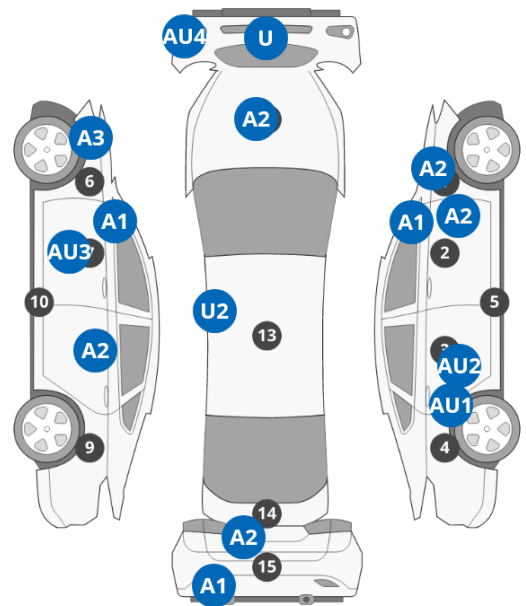
<p>A : Scratch AU : Scratch & Dent B : Modified C : Corrosion G : Stone chip P : Faded S : Rust SC : Rust & Corrosion U : Dent X : Defective Y : Crack, Gap</p>
<p>Remarks Ceiling - Grime - Medium / (R) Front Trim - Grime - Small / (R) Front Floor Mat - Grime - Small / Rear Seat - Grime - Medium / (L) Front Trim - Grime - Medium / (L) Front Floor Mat - Worked - Small</p>	<p>Remarks (L) Front Door, Molding - Scratch & Dent - Medium / (L) Rear Door, Molding - Scratch - Small / (L) Mirror - Scratch - Minimal / Trunk Hood, Rear Gate - Scratch - Small / (R) Rear Fender, Molding - Scratch & Dent - Minimal / (R) Rear Door, Molding - Scratch & Dent - Small / (R) Front Door, Molding - Scratch - Small / (L) Front Fender, Molding - Scratch - Medium / Front Bumper, Grille, Lamps - Scratch & Dent - Large / (R) Front Fender, Molding - Scratch - Small / (R) Mirror - Scratch - Minimal / Bonnet, Headlight - Scratch - Small / Roof - Dent - Small / Overall Exterior - Faded(Color, Gloss) - Yes / Rear Bumper, Lamps, Panels - Scratch - Minimal / Member (Bolted) - Dent - Yes</p>
