## General Information

| Make | Toyota | Model | Vios |
| YOM | 2022 | Mileage | 19,882 |

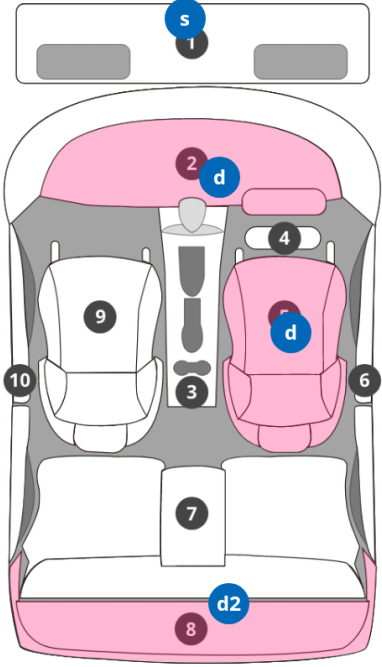
| <b>Interior Evaluation :</b> <span style="color: red; font-weight: bold;">B</span> | <b>Exterior Evaluation :</b> <span style="color: red; font-weight: bold;">C</span> |
| <b>Remarks</b><br>Overall Interior - Smell - Yes / Dashboard - Traces of Adhesive Tape - Yes / Trunk Room - Loose, Deformed, Grime - Small / (R) Front Seat - Worn - Yes | <b>Remarks</b><br>Front Bumper, Grille, Lamps - Scratch & Dent - Large / (R) Mirror - Scratch - Minimal / (R) Front Door, Molding - Scratch - Minimal / (R) Rear Door, Molding - Scratch - Small / Rear Bumper, Lamps, Panels - Scratch & Dent - Large / Trunk Hood, Rear Gate - Scratch - Small / (L) Rear Door, Molding - Scratch - Minimal / (L) Front Fender, Molding - Scratch - Minimal / (L) Mirror - Scratch - Minimal / Bonnet, Headlight - Scratch - Minimal / Roof - Dent - Small |

| Inspector Notes |
|---|
| front right seat& rear seat dirt marks |
