## General Information

| Make | MG | Model | ZS |
| Registration No. | NGN3215 | Chassis No. | LSJW74U9XLLZ041692 |

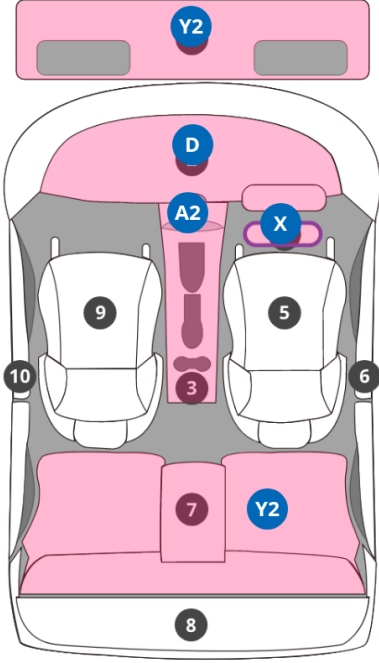
| Interior Evaluation : <b>B</b> | Exterior Evaluation : <b>B</b> |
| <p><b>Remarks</b><br/>Mat Other - Missing - Yes / Dashboard - Traces of Adhesive Tape - Yes / Rear Seat - Grime - Small / Ceiling - Grime - Small / Console, Switchs, Vents - Worn, Scratch, Cut, Crack - Small</p> | <p><b>Remarks</b><br/>(L) Rear Fender - Repair Traces - Yes / (R) Mirror - Scratch - Minimal / (L) Rear Door, Molding - Scratch - Small / (L) Front Door, Molding - Scratch - Minimal / (L) Front Fender, Molding - Scratch - Minimal / (R) Rear Door, Molding - Scratch - Small / (R) Front Door, Molding - Scratch - Small / (R) Rear Fender, Molding - Scratch - Small / (L) Rear Fender, Molding - Scratch &amp; Dent - Small / Rear Bumper, Lamps, Panels - Scratch - Small / Front Bumper, Grille, Lamps - Scratch - Minimal / (R) Front Fender, Molding - Scratch - Minimal</p> |
