General Information

Make	Mercedes-Benz	Model	E 200
YOM	2017	Odo Meter Reading	11,801
Registration No.	NCN7988	Chassis No.	WDD2130421A125329
CC	2.0	Transmission	A/T
Fuel Type	Gas	Type of Body	Sedan
Colour	White

Body / Panel Condition

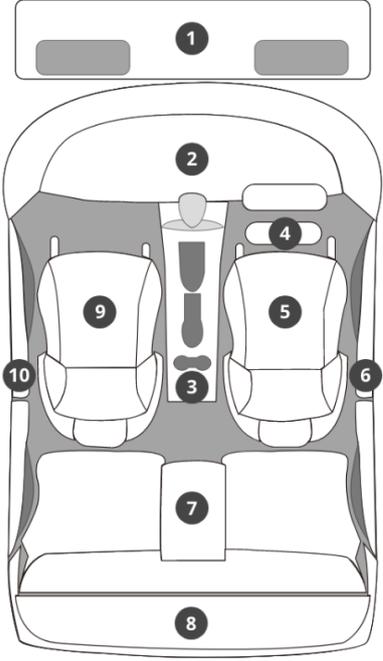
Interior Evaluation : A	Exterior Evaluation : C

<p>a : Cut, Fray d : Loose, Deformed k : Animal Hair s : Smell t : Cigarette Burns x : Defective y : Stain</p>

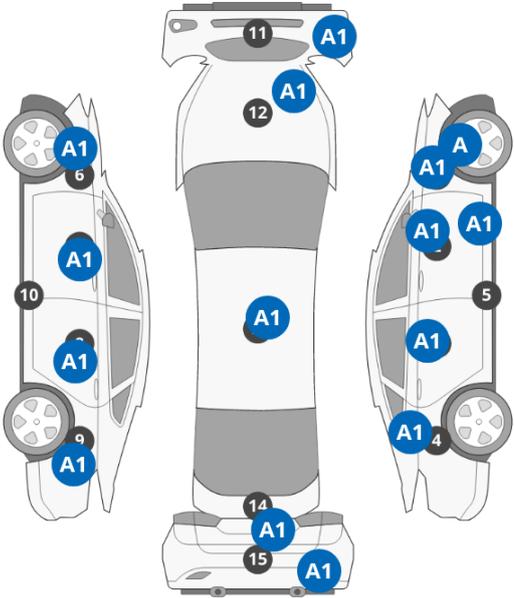
<p>A : Scratch AU : Scratch & Dent B : Modified C : Corrosion G : Stone chip P : Faded S : Rust SC : Rust & Corrosion U : Dent X : Defective Y : Crack, Gap</p>
Remarks Defects not found	Remarks Trunk Hood, Rear Gate - Scratch - Minimal / (L) Rear Door, Molding - Scratch - Minimal / (L) Front Door, Molding - Scratch - Minimal / (L) Front Fender, Molding - Scratch - Minimal / Bonnet, Headlight - Scratch - Minimal / (R) Front Fender, Molding - Scratch - Minimal / (R) Front Tyre - Crack, Cut - Yes / (R) Step, In-panel, Side Spoiler - Scratch - Minimal / (R) Front Door, Molding - Scratch - Minimal / (R) Rear Door, Molding - Scratch - Minimal / (R) Rear Fender, Molding - Scratch - Minimal / Rear Bumper, Lamps, Panels - Scratch - Minimal / (L) Rear Fender, Molding - Scratch - Minimal / Roof - Scratch - Minimal / Front Bumper, Grille, Lamps - Scratch - Minimal
