## General Information

| Make | Toyota | Model | Lite Ace |
| Registration No. | DBO1655 | Chassis No. | MHKU3FE10PK005745 |

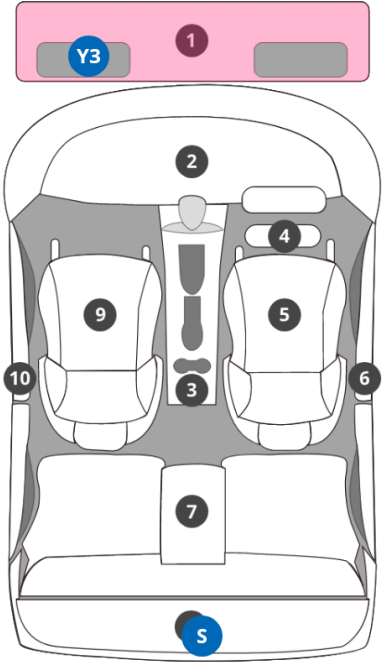
| Interior Evaluation : <span style="color: red;">C</span> | Exterior Evaluation : <span style="color: red;">E</span> |
|---|---|
| <b>Remarks</b><br>Overall Interior - Worn as per age - Yes / Ceiling - Grime - Medium / Overall Interior - Smell - Yes | <b>Remarks</b><br>(R) Front Fender, Molding - Scratch - Minimal / (R) Front Door, Molding - Scratch - Minimal / (R) Center Panel - Scratch - Minimal / (R) Side Gate - Scratch & Dent - Large / Rear Bumper, Lamps, Panels - Scratch - Medium / Rear Gate - Scratch - Minimal / (L) Side Gate - Scratch - Medium / Cargo Bed Floor - Scratch & Dent - Large / Cab Back Panel - Scratch & Dent - Large / Roof - Scratch - Medium / (L) Front Door, Molding - Scratch - Small / (L) Front Fender, Molding - Scratch & Dent - Large / Front Bumper, Grille, Lamps - Scratch & Dent - Large / Front Panel - Scratch - Minimal |

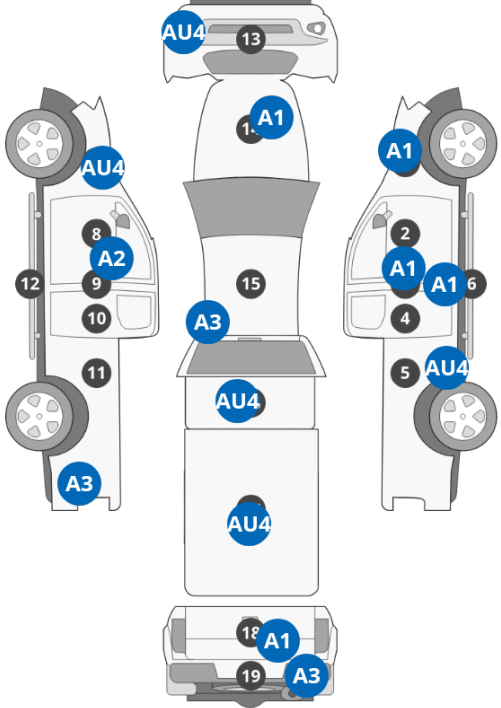
with warranty booklet, with jack and tools, with spare tire, with LTO plate, scratches on headlight, cracked tail light, plate and reverse light issue, left and back door issue, battery weak, power steering issue due to weak battery, front right panel bent
