## General Information

| Make | Toyota | Model | Vios |

## Body / Panel Condition

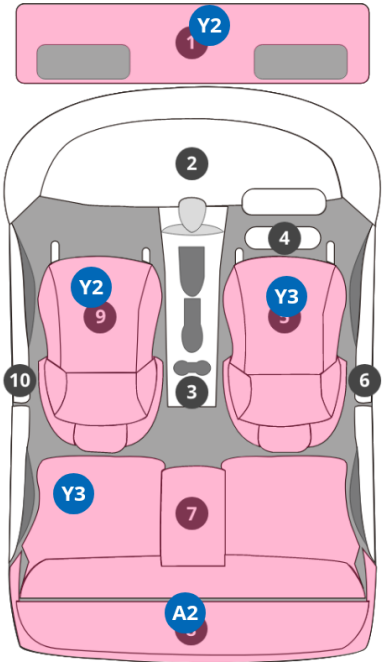
| <b>Interior Evaluation :</b> <b>B</b> | <b>Exterior Evaluation :</b> <b>E</b> |
| <b>Remarks</b><br>Trunk Room - Worn, Scratch, Cut, Crack - Small / Rear Seat - Grime - Medium / (R) Front Seat - Grime - Medium / Ceiling - Grime - Small / (L) Front Seat - Grime - Small | <b>Remarks</b><br>(R) Front Fender - Repair Traces - Yes / (R) Front Fender, Molding - Repair mark - Yes / (R) Front Fender, Molding - Scratch - Small / (R) Front Door, Molding - Scratch & Dent - Small / (R) Rear Door, Molding - Scratch & Dent - Small / (R) Rear Fender, Molding - Scratch - Medium / Rear Bumper, Lamps, Panels - Scratch - Medium / Trunk Hood, Rear Gate - Scratch & Dent - Medium / (L) Rear Fender, Molding - Scratch - Medium / (L) Rear Door, Molding - Scratch & Dent - Medium / (L) Step, In-panel, Side Spoiler - Scratch & Dent - Small / (L) Front Door, Molding - Scratch - Medium / (L) Front Fender, Molding - Scratch & Dent - Minimal / Roof - Scratch - Minimal / Front Bumper, Grille, Lamps - Scratch - Small / Bonnet, Headlight - Scratch - Minimal |

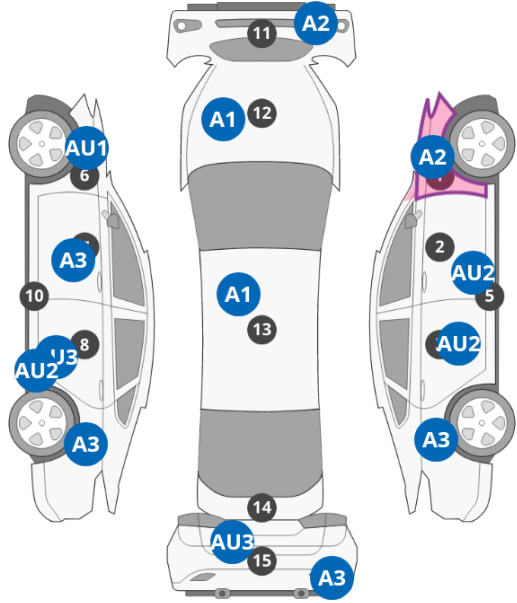
| with LTO plate, no warranty booklet, with jack, no tools, with spare tire, damaged tail light, busted foglamps and parklight, weak battery |
