## General Information

| Make | Toyota | Model | Vios |
| Registration No. | NFE6832 | Chassis No. | PA1B18F35N4187701 |

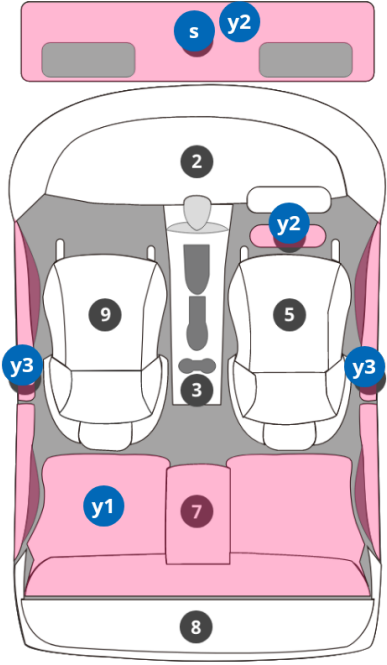
| <b>Remarks</b><br>Overall Interior - Smell - Yes / (L) Front Floor Lag - Grime - Small / Rear Seat - Grime - Minimal / Ceiling - Grime - Small / (L) Front Trim - Grime - Medium / (R) Front Trim - Grime - Medium | <b>Remarks</b><br>Front Bumper, Grille, Lamps - Scratch - Medium / (L) Mirror - Scratch - Minimal / (L) Front Door, Molding - Scratch - Minimal / (L) Rear Fender, Molding - Scratch - Minimal / Rear Bumper, Lamps, Panels - Scratch - Medium / (R) Rear Door, Molding - Scratch - Medium / Roof - Dent - Minimal |

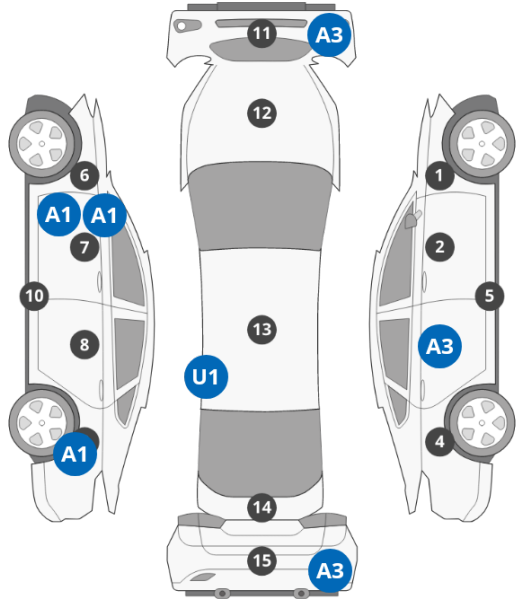
| Inspector Notes |
|---|
| light scratches around the exterior. adhesive marks at the windshield. aftermarket rear passenger mirrors. front passenger tint crack |
