## General Information

| Make | Toyota | Model | Vios |
| Registration No. | NHU3699 | Chassis No. | PA1B18F32R4270458 |

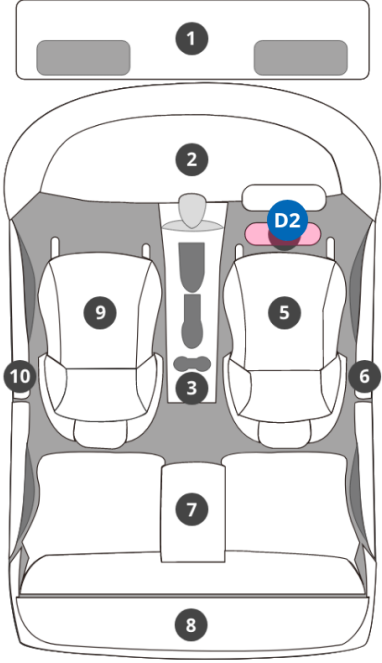
| <b>Remarks</b><br>(L) Front Floor Mat - Worked - Small | <b>Remarks</b><br>(R) Front Fender, Molding - Scratch - Minimal / (R) Front Door, Molding - Scratch - Minimal / (R) Rear Door, Molding - Scratch - Minimal / Rear Bumper, Lamps, Panels - Scratch - Minimal / Trunk Hood, Rear Gate - Scratch - Small / (L) Rear Fender, Molding - Scratch & Dent - Small / (L) Rear Door, Molding - Scratch & Dent - Small / (L) Front Door, Molding - Scratch - Minimal / Front Bumper, Grille, Lamps - Scratch - Small / Bonnet, Headlight - Scratch - Small / Roof - Scratch - Minimal |

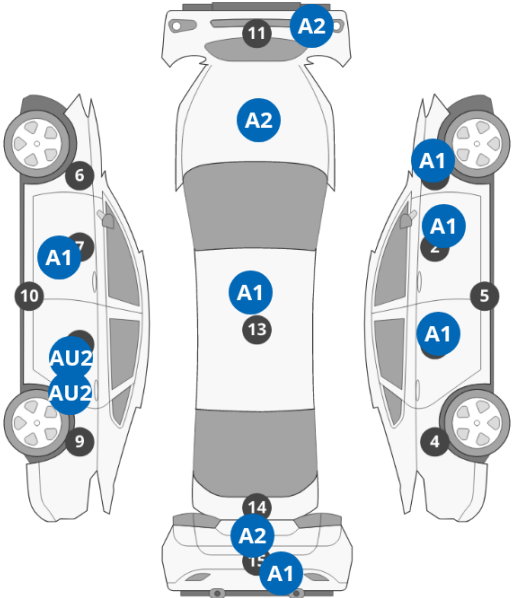
with warranty booklet and LTO Plate, Jack and Sparetire. no Tools and Scratch headlight and tail light. wiper not working.
