## General Information

| Make | Toyota | Model | Vios |
| Registration No. | NKD8970 | Chassis No. | PA1B18F30R4258311 |

## Body / Panel Condition

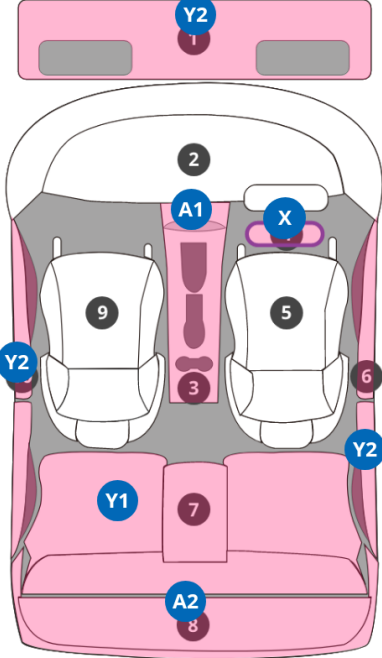
| Interior Evaluation : <span style="float: right;">B</span> | Exterior Evaluation : <span style="float: right;">E</span> |
| <p>a : Cut, Fray d : Loose, Deformed k : Animal Hair s : Smell t : Cigarette Burns x : Defective y : Stain</p> | <p>A : Scratch AU : Scratch &amp; Dent B : Modified C : Corrosion G : Stone chip P : Faded S : Rust SC : Rust &amp; Corrosion U : Dent X : Defective Y : Crack, Gap</p> |
| <p><b>Remarks</b></p> <p>Rear Seat - Grime - Minimal / Trunk Room - Worn, Scratch, Cut, Crack - Small / Ceiling - Grime - Small / (R) Rear Trim - Grime - Small / (R) Front Floor Mat - Missing - Yes / Mat Other - Missing - Yes / (L) Front Trim - Grime - Small / Console, Switchs, Vents - Worn, Scratch, Cut, Crack - Minimal</p> | <p><b>Remarks</b></p> <p>(R) Front Fender, Molding - Scratch - Medium / (R) Front Door, Molding - Scratch - Minimal / (R) Mirror - Scratch - Minimal / (R) Rear Door, Molding - Scratch - Minimal / (R) Rear Fender, Molding - Rust, Corrosion - Small / Rear Bumper, Lamps, Panels - Scratch - Large / Trunk Hood, Rear Gate - Scratch - Small / (L) Rear Fender, Molding - Scratch - Minimal / (L) Rear Door, Molding - Scratch - Large / (L) Front Door, Molding - Scratch - Minimal / (L) Mirror - Scratch - Minimal / Front Bumper, Grille, Lamps - Scratch - Large / Bonnet, Headlight - Scratch - Small / (L) Front Fender, Molding - Scratch &amp; Dent - Large</p> |
