## General Information

| Make | Toyota | Model | Innova |
| YOM | 2024 | Odo Meter Reading | 25,199 |

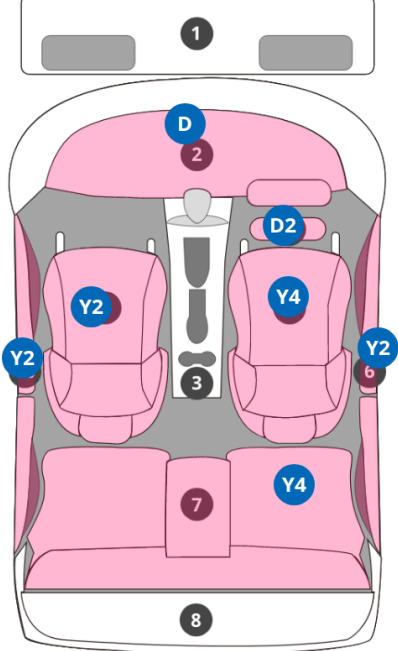
| Interior Evaluation : <span style="color: red;">C</span> | Exterior Evaluation : <span style="color: red;">C</span> |
| <b>Remarks</b><br>(R) Front Seat - Grime - Large / Rear Seat - Grime - Large / (L) Front Seat - Grime - Small / (L) Front Floor Mat - Worked - Small / (L) Front Trim - Grime - Small / (R) Front Trim - Grime - Small / Dashboard - Traces of Adhesive Tape - Yes | <b>Remarks</b><br>(R) Front Fender, Molding - Scratch - Minimal / (R) Mirror - Scratch - Minimal / (R) Rear Door, Molding - Scratch - Small / (R) Rear Fender, Molding - Scratch - Minimal / Rear Bumper, Lamps, Panels - Scratch - Small / Trunk Hood, Rear Gate - Scratch & Dent - Small / (L) Rear Fender, Molding - Scratch - Minimal / (L) Front Door, Molding - Scratch - Small / (L) Front Fender, Molding - Scratch - Minimal / Bonnet, Headlight - Scratch - Small / Roof - Scratch - Minimal / Front Bumper, Grille, Lamps - Scratch & Dent - Small / (R) Front Wheel, Cover - Scratch, Corrosion - Small / (L) Mirror - Crack - Damaged |

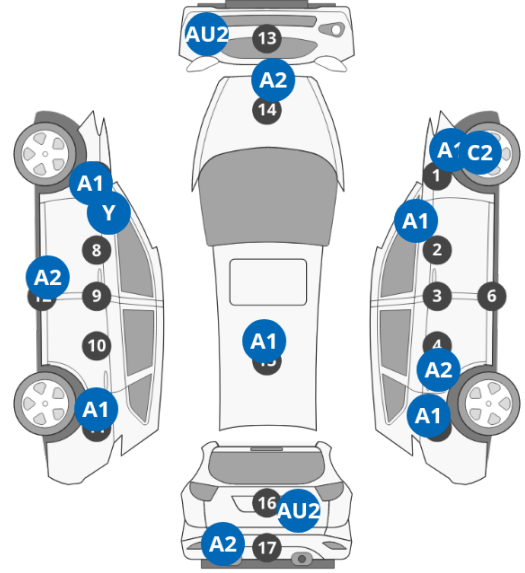
| Inspector Notes |
|---|
| with LTO plate, no warranty booklet, no jack and tools, with spare tire, damaged left side mirror, busted headlights high and low beam |
