## General Information

| Make | Toyota | Model | Vios |
| Registration No. | DAV1242 | Chassis No. | PA1B18F31M4142401 |

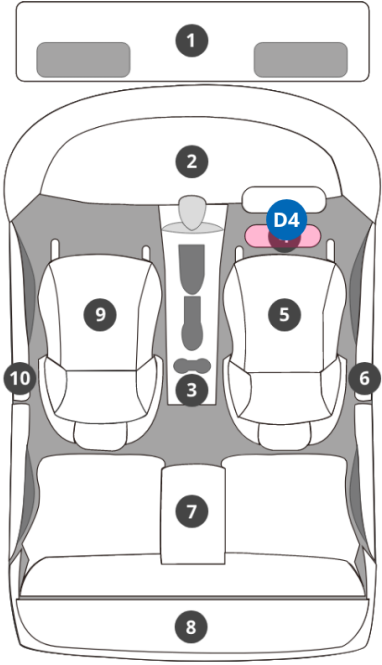
| Interior Evaluation : <span style="color: red;">C</span> | Exterior Evaluation : <span style="color: red;">B</span> |
| <b>Remarks</b><br>Overall Interior - Worn as per age - Yes / (L) Front Floor Mat - Worked - Large | <b>Remarks</b><br>(R) Rear Fender, Molding - Dent - Small / (R) Front Door, Molding - Scratch - Minimal / (R) Rear Door, Molding - Scratch - Small / Trunk Hood, Rear Gate - Scratch - Minimal / Rear Bumper, Lamps, Panels - Scratch - Minimal / (L) Rear Door, Molding - Scratch - Minimal / (L) Rear Fender, Molding - Scratch - Minimal / (L) Front Door, Molding - Scratch - Minimal / (L) Front Fender, Molding - Scratch - Minimal / Bonnet, Headlight - Scratch - Small / Front Bumper, Grille, Lamps - Scratch - Minimal / (R) Front Fender, Molding - Scratch - Minimal / Roof - Scratch - Small |

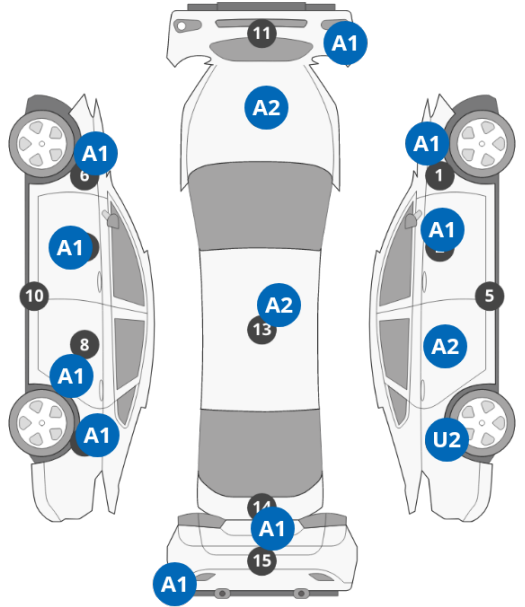
with LTO plate and Jack, Sparetire and incomplete tools. without warranty booklet and scratch tail lights and head lights.
