## General Information

| Make | Toyota | Model | Vios |
| YOM | 2008 | Odo Meter Reading | 171,966 |
| Registration No. | ZPB679 | Chassis No. | NCP92-9005936 |

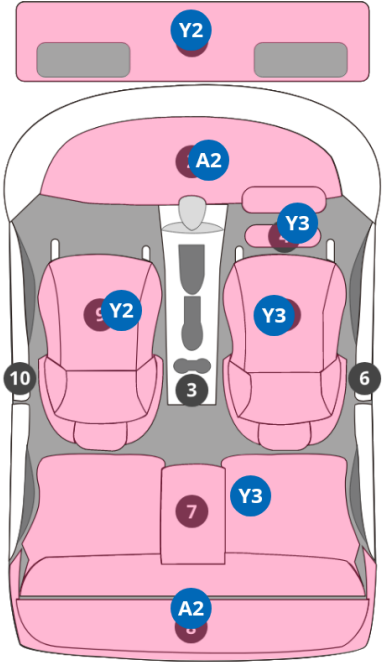
| Interior Evaluation : <b>C</b> | Exterior Evaluation : <b>E</b> |
|---|---|
| <p><b>Remarks</b></p> <p>Rear Seat - Grime - Medium / (R) Front Seat - Grime - Medium / Trunk Room - Worn, Scratch, Cut, Crack - Small / (L) Front Seat - Grime - Small / (L) Front Floor Mat - Grime - Medium / Ceiling - Grime - Small / Dashboard - Worn, Scratch, Cut, Crack - Small</p> | <p><b>Remarks</b></p> <p>(R) Front Fender - Repair Traces - Yes / Bonnet - Repair Traces - Yes / (L) Front Fender - Repair Traces - Yes / Front Bumper, Grille, Lamps - Scratch &amp; Dent - Large / (R) Front Fender, Molding - Scratch - Medium / (R) Mirror - Scratch - Small / (R) Rear Fender, Molding - Scratch - Medium / (R) Rear Door, Molding - Scratch - Medium / (R) Front Door, Molding - Scratch - Medium / Rear Bumper, Lamps, Panels - Repair mark - Yes / Rear Bumper, Lamps, Panels - Scratch - Large / Trunk Hood, Rear Gate - Scratch &amp; Dent - Medium / (L) Rear Fender, Molding - Scratch &amp; Dent - Medium / (L) Rear Door, Molding - Scratch &amp; Dent - Medium / (L) Front Door, Molding - Scratch - Medium / (L) Front Fender, Molding - Scratch &amp; Dent - Medium / Bonnet, Headlight - Scratch - Medium / Roof - Scratch - Medium</p> |

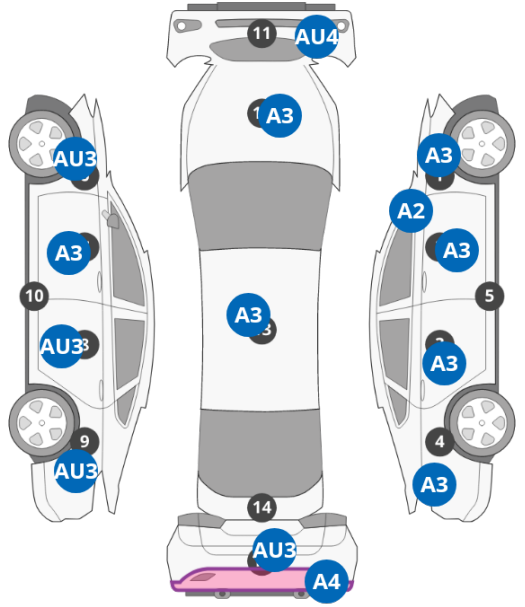
with LTO plate/with spare tire/with jack and incomplete tools/with warranty booklet/with reverse camera not working/roof faded color/bonnet faded color/trunk hood faded color/open pipe/engine number unable to confirm
