## General Information

| Make | Toyota | Model | Vios |

## Body / Panel Condition

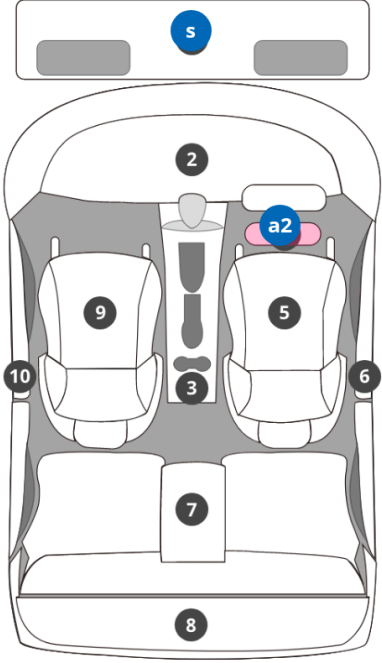
| <b>Remarks</b><br>Overall Interior - Smell - Yes / (L) Front Floor Lag - Cut, Crack - Small | <b>Remarks</b><br>Front Bumper, Grille, Lamps - Scratch - Medium / (L) Step, In-panel, Side Spoiler - Scratch - Small / Rear Bumper, Lamps, Panels - Scratch - Medium / (R) Rear Door, Molding - Scratch & Dent - Minimal / Roof - Scratch - Small |

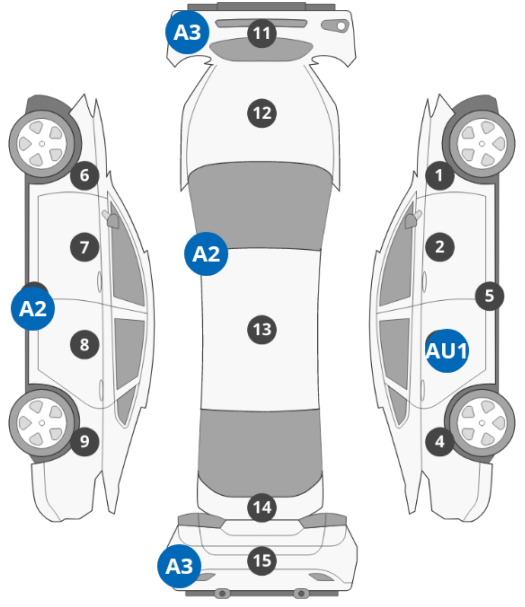
| Inspector Notes |
|---|
| hairline scratches around the exterior. |
