## General Information

| Make | Toyota | Model | Hiace |
| Registration No. | DBF7635 | Chassis No. | JTFNAFAP6P8039812 |

## Body / Panel Condition

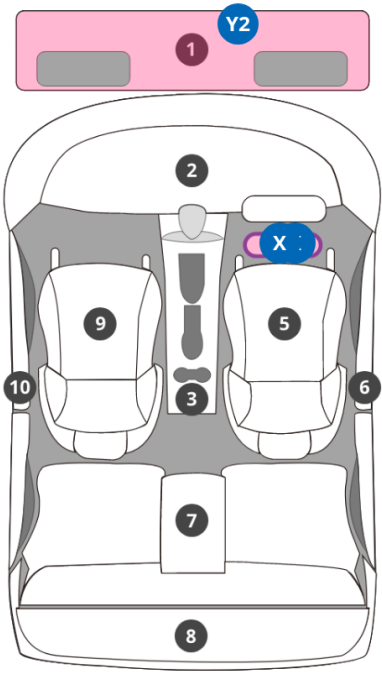
| Interior Evaluation : <b>B</b> | Exterior Evaluation : <b>D</b> |
| <b>Remarks</b><br>Ceiling - Grime - Small / (L) Front Floor Mat - Missing - Yes / Mat Other - Missing - Yes | <b>Remarks</b><br>(L) Front Door, Molding - Scratch - Medium / (L) Front Fender, Molding - Scratch & Dent - Small / (L) Rear Fender, Molding - Scratch & Dent - Medium / Rear Bumper, Lamps, Panels - Scratch & Dent - Small / Trunk Hood, Rear Gate - Scratch & Dent - Small / (R) Rear Fender, Molding - Scratch & Dent - Large / (R) Rear Door, Molding - Scratch & Dent - Medium / (R) Step, In-panel, Side Spoiler - Dent - Minimal / (R) Front Door, Molding - Scratch - Small / Bonnet, Headlight - Scratch & Dent - Minimal / (R) Front Fender, Molding - Scratch - Small / Front Bumper, Grille, Lamps - Scratch - Large |

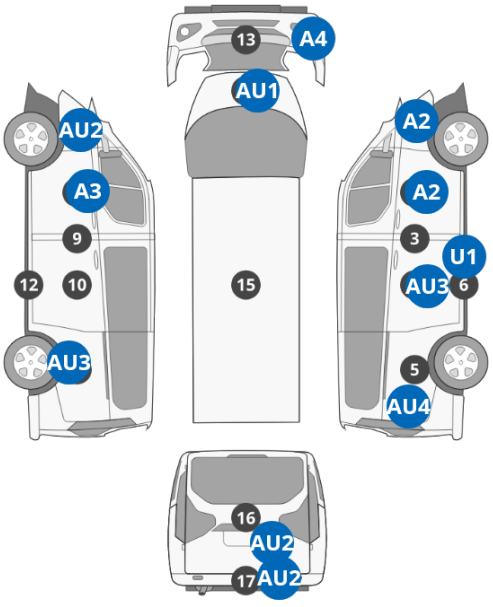
With warranty booklet and LTO Plate, Sparetire. no Tools and Jack , Crack tail light, scratch headlight and tail light.
