## General Information

| Make | Toyota | Model | Vios |
| YOM | 2024 | Mileage | 7,339 |

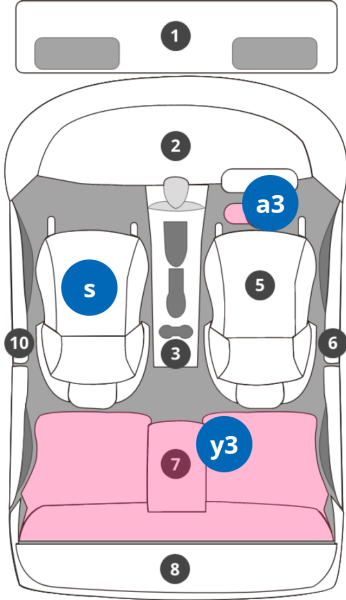
| Interior Evaluation : <span style="color: red;">B</span> | Exterior Evaluation : <span style="color: red;">A</span> |
|---|---|
| <b>Remarks</b><br>Overall Interior - Smell - Yes / (L) Front Floor Mat - Cut, Crack - Medium / Rear Seat - Grime - Medium | <b>Remarks</b><br>(L) Front Door - Repair Traces - Yes / Rear Bumper, Lamps, Panels - Scratch - Small / (R) Mirror - Scratch - Minimal / Front Bumper, Grille, Lamps - Scratch - Small / (R) Rear Fender, Molding - Scratch & Dent - Minimal |

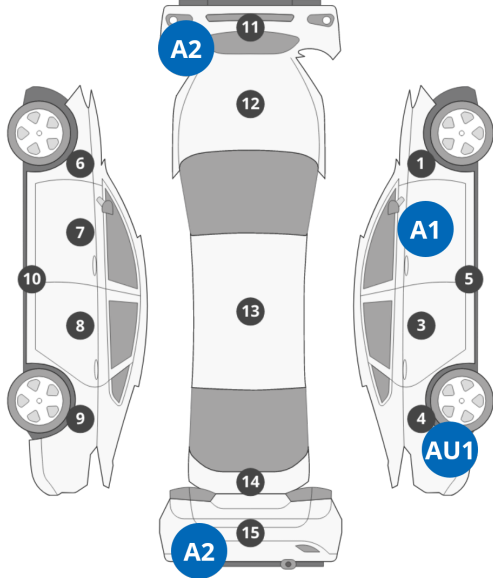
swirl marks and hairline scratches around the exterior,/ with rain visor/
