## General Information

| Make | Suzuki | Model | Carry |
| Registration No. | NKE1452 | Chassis No. | MHYDC61T4SJ210453 |

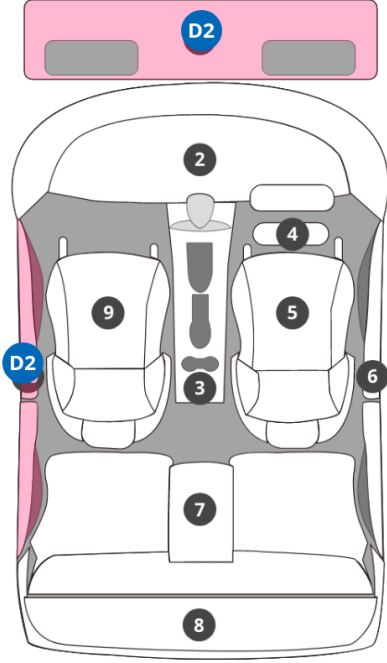
| Interior Evaluation : <b>A</b> | Exterior Evaluation : <b>B</b> |
| <b>Remarks</b><br>(L) Front Trim - Worked - Small / Ceiling - Crinkle - Small | <b>Remarks</b><br>(R) Mirror - Scratch - Minimal / (R) Front Door, Molding - Scratch - Minimal / (R) Center Panel - Scratch - Minimal / (R) Side Gate - Scratch - Medium / Rear Gate - Scratch - Small / Rear Bumper, Lamps, Panels - Scratch - Minimal / (L) Side Gate - Scratch - Minimal / Cargo Bed Floor - Scratch - Small / (L) Center Panel - Scratch - Minimal / (L) Front Door, Molding - Scratch - Minimal / Front Bumper, Grille, Lamps - Scratch - Minimal / Roof - Scratch & Dent - Medium / (R) Front Fender, Molding - Scratch - Minimal |
